Collision

CRASH BEHAVIOUR IN A CRASH COMPARISON:

THE NEW BIOFIDELIC DUMMY IN DIFFERENT SCENARIOS OF ACCIDENTS INVOLVING PASSENGER CARS AND PEDESTRIANS

Annika Kortmann

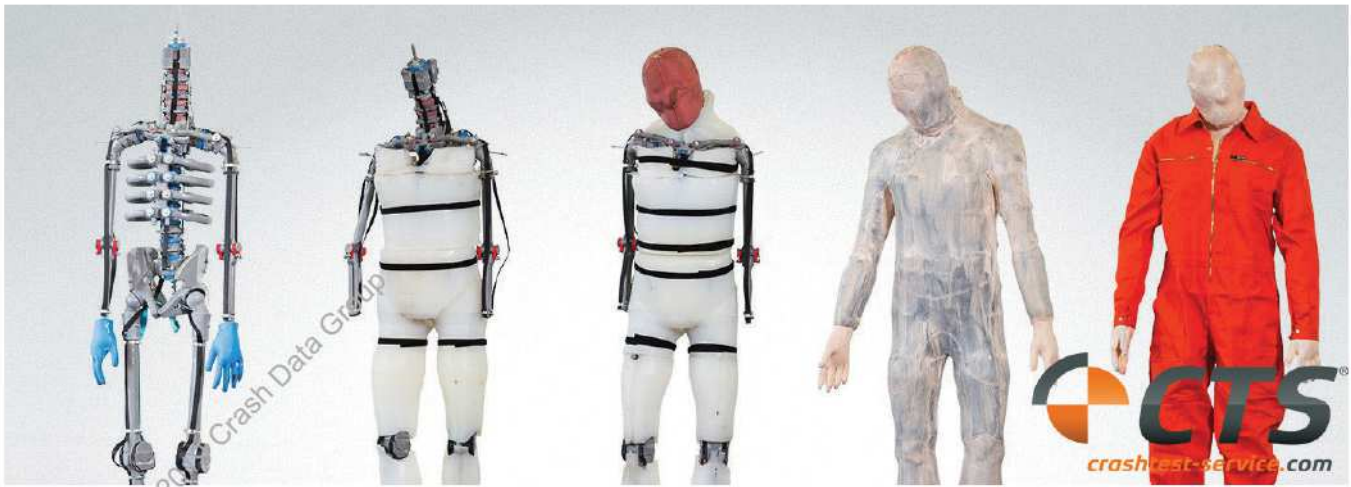
Figure 2: Each stage of the biofidelic dummy production process

and development of the so-called biofidelic dummy from Dr. Michael Weyde and have since July 2017 their own manufacturing laboratory. Due to the special construction, the biofidelic dummy has a very good comparability with the real human body. The used materials are selected according to their physical properties in order to reproduce the human “body parts” as precisely as possible. The “bones” of the dummy are, for example, made of epoxy resin and an admixture of aluminium powder in order to be able to reproduce the breaking resistance of human bones as realistically as possible. Also ligaments and tendons in the form of polypropylene straps form part of the biofidelic dummy. The reproduction of the soft tissues is accomplished by silicone and acrylic. Since every dummy is assembled by hand, step for step (see Figure 1 sidebar), it is also possible to deviate from the standard construction of the dummy with a height of 1,75 m and a weight of 79 kg to make custom-made models in terms of height and weight. The production time of a standard biofidelic dummy is approximately 2 weeks, custom-made products can be achieved in around 4 weeks. An example illustrating each stage of the production process is shown in Figure 2. Due to the in house production by CTS, the dummy can be equipped with measuring technology during the finishing procedure, so that collision induced accelerations and forces occurring in the area of the cervical spine can be measured. By installing special sensors, the pressure can be measured which impacts, inter alia, areas such as the chest or individual segments of the spine during the collision.

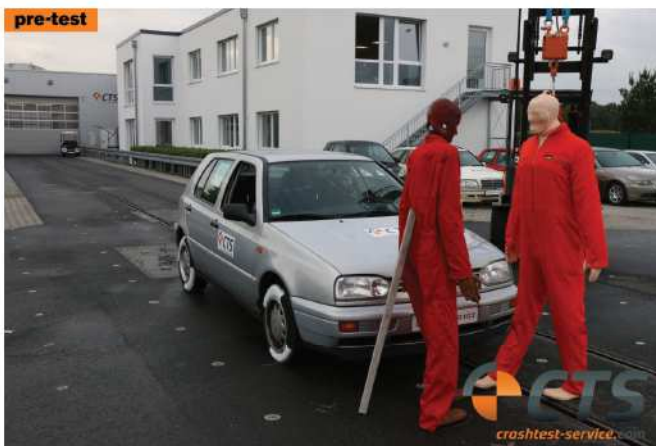
Figure 3: The impact configuration with a conventional (NAMI-) dummy in vehicle plan view on the left side

The Federal Statistical Office prepared a statistic of collisions between vehicles and pedestrians from the year 2013². From a total of 28,805 accidents, 95 % of those accidents happened in urban areas and only 5 % in suburban areas. For this reason, for the first crash test comparison between a biofidelic and NAMI-dummy, a scenario was chosen in which a VW Golf III collided head on with an urban-usual speed of 50 km/h simultaneously with the two dummies. Figure 3 shows the impact configuration with a conventional (NAMI-) dummy in vehicle plan view on the left side. The biofidelic dummy is on the right side. The differences in the movement sequences of the dummies during the collision, in particularly in the carrying-phase, were filmed separately and are shown in Figure 4 and Figure 5. Figure 4 shows the movement sequences of the conventional dummy. Immediately after the impact, the legs of the dummy raise from the ground, a pedestrian accidents' typical "undergoing" of the legs does not take place. Due to the rigid construction of the NAMI-dummy, the dummy does not cling to the car bonnet and collides in an almost stretched out position with the head against the windshield. In the last sequence in Figure 4 it is clear to see that the body of the NAMI during the impact of the head has a significant clearance to the bonnet. The movement sequences of the biofidelic dummy by the impact of a passenger car (Figure 5) resembles the impact behaviour of a real pedestrian, by which the standing leg is pulled under the passenger car and the dummy clings to the bonnet during

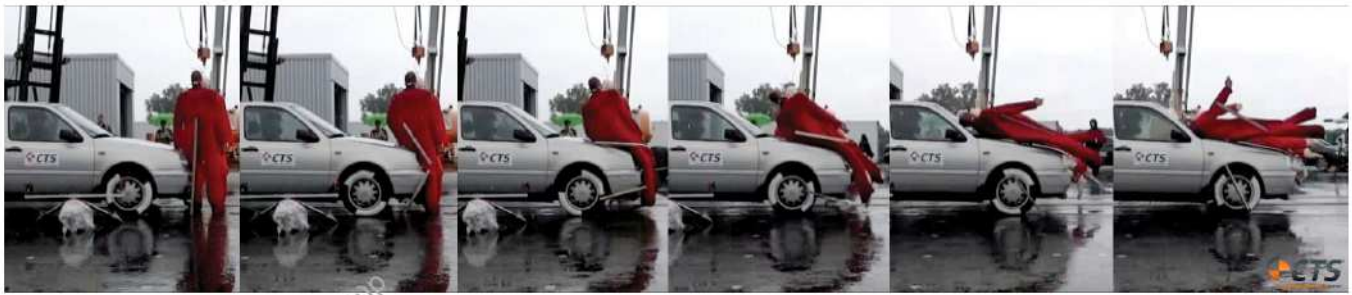
Figure 4: The movement sequences of the conventional dummy

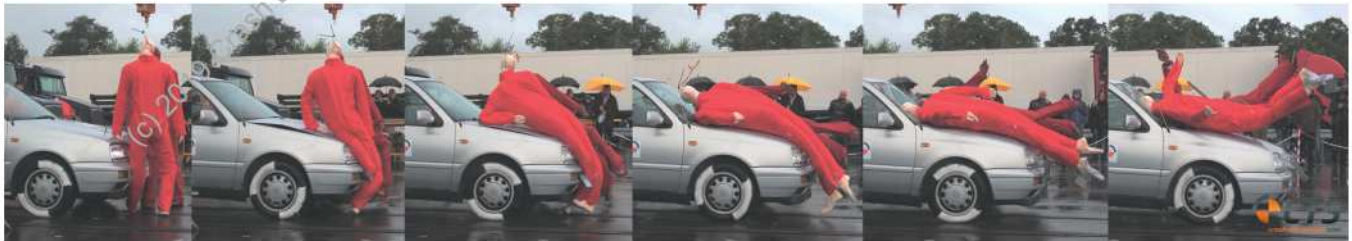
Figure 5: The movement sequences of the biofidelic dummy impacted by a passenger car (mirrored)

the course of the collision. The head impact occurs with a movement from the top downwards whilst the body makes contact with the bonnet.

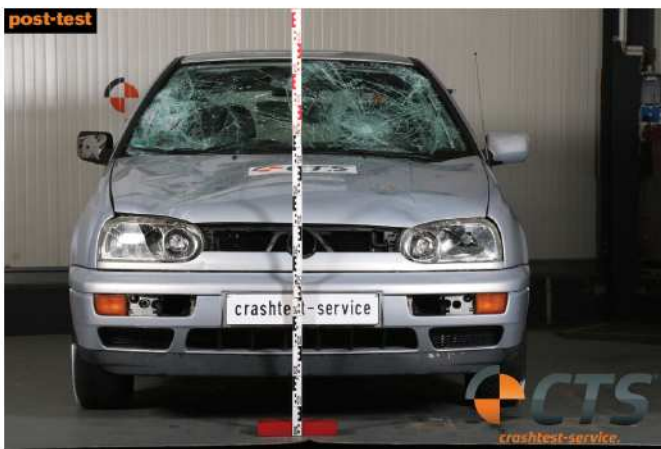
Figure 6: A top view of the vehicle front of the VW Golf III after the collision

Also the comparison of the damages on the left and right side of the passenger car after the collision gives a much more realistic accident representation through the use of the biofidelic dummy. Figure 6 shows a top view of the vehicle front of the VW Golf III after the collision: left side; the damage pattern caused by the NAMI, right side; the damage pattern caused by the biofidelic dummy. It clearly shows that the passenger car in the contact area with the NAMI is much more severely damaged. Also the fracture pattern in the windscreen is diffused on the left side and the detail view in Figure 7 shows clearly that the NAMI, in comparison to the biofidelic dummy, actually penetrates the windscreen with its head. As a result of the clinging of the biofidelic dummies body during the collision, the contact of the hips and shoulder can be recognised afterwards

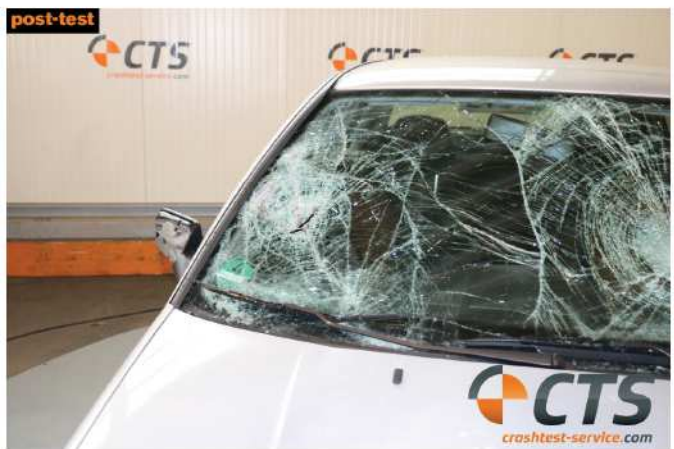
Figure 7: Fracture pattern in the windscreen

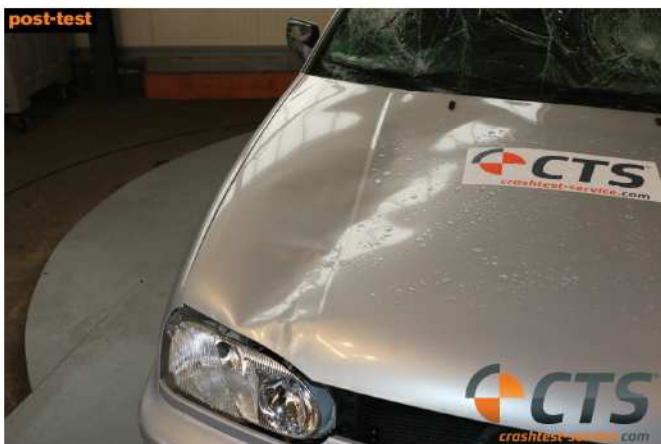
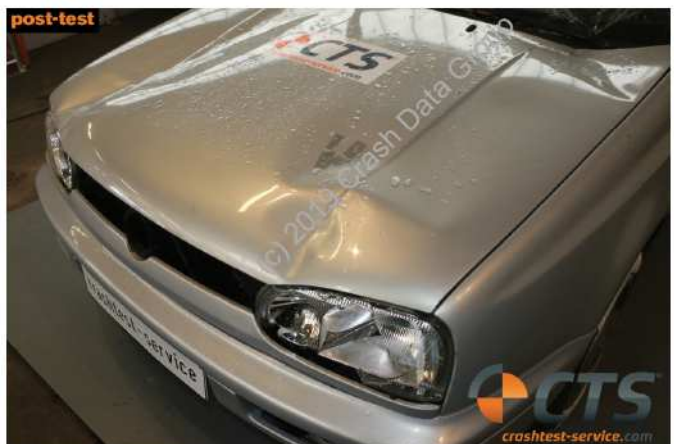
Figure 8: Damages caused to the bonnet

in the damages caused to the bonnet, see Figure 8 (right image). During the impact of the NAMI on the car bonnet, the damages caused are extensive and also include several scratches, which would not occur in a real pedestrian accident (Figure 8, left image).

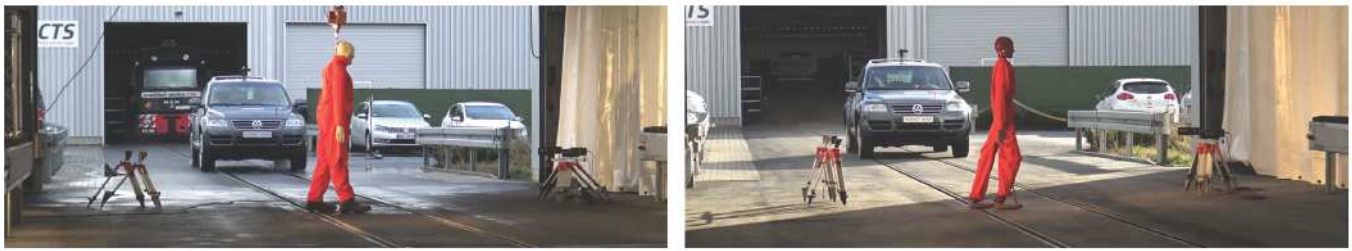
Figure 9: The test setup, where a biofidelic and a NAMI-dummy under identical conditions are impacted with a VW Touareg

Figure 9 shows the test setup, where a biofidelic and a NAMI-dummy under identical conditions are impacted with a VW Touareg (Type 7L) at a velocity of just over 40 kph. Also the comparison of the impact configurations shown in Figure 10 validates the identical test setup. By means of the optical comparison of the impact configurations from Figure 3 and Figure 10 it becomes evident, that the lower edge of the bonnet of the VW Touareg around is 25 cm higher than the VW Golf III. In order to determine whether the previous rolling-off and clinging-on behaviour of the biofidelic dummy to the bonnet also takes place with an SUV front, the study of the movement sequences during the collision is of crucial importance.

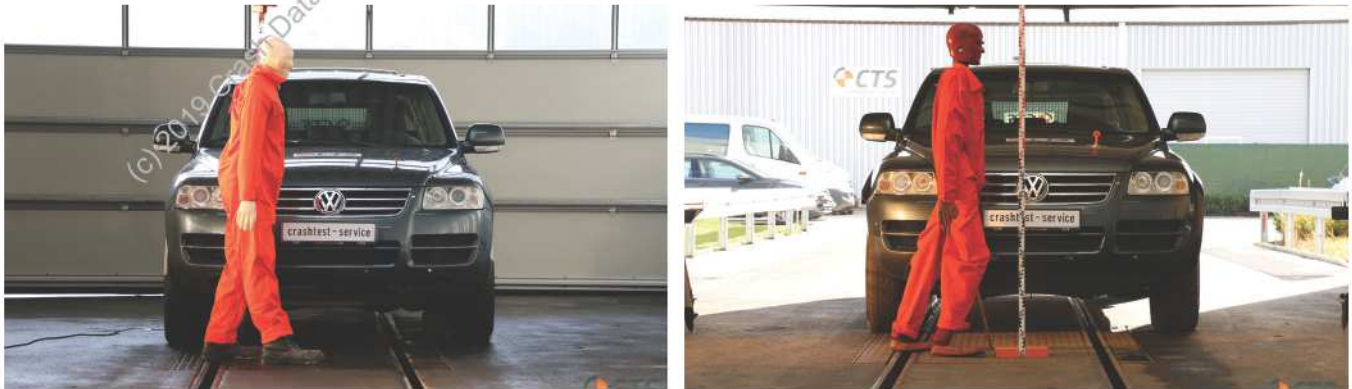
Figure 10: The test setup, where a biofidelic and a NAMI-dummy under identical conditions are impacted with a VW Touareg

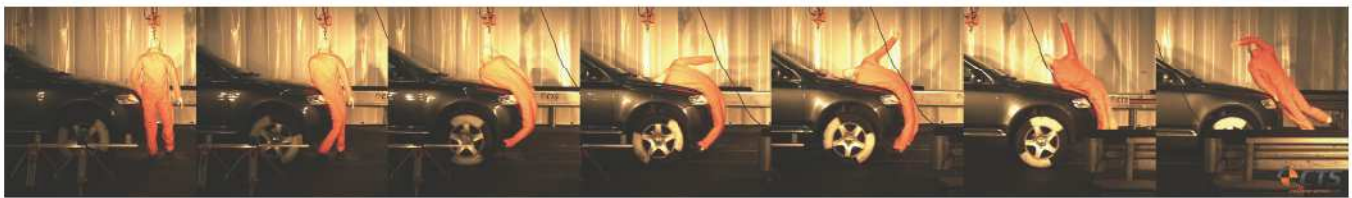
Figure 11: Movement sequences during the test with the biofidelic dummy

As also previously in the crash test with the VW Golf III, a high-speed recording was made from the side view taken at the height of the collision, the movement sequences are correspondingly shown in Figure 11 and 12. In Figure 11 it becomes apparent that despite of the higher bonnet, as previously observed, the clinging of the biofidelic dummy on the SUV front and bonnet also takes place. The

typical undergoing of the feet is also present in the crash with this vehicle type. During the course of the collision, the dummy adapts itself with the contour of the vehicle front, whereby the upper body presses from the top on the bonnet and the head impacts the bonnet with such a momentum in a sideways tilting movement. After the main exchange of force the movement of the dummy is opposed and it is then thrown off forwards in the SUV's direction of travel.

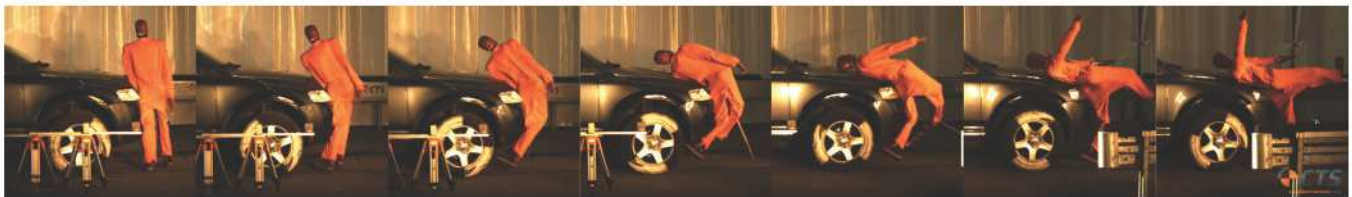
Figure 12: Movement sequences during the test with the NAMI-dummy

Comparing the previous movement sequences of the biofidelic dummy with the NAMI-dummy based on the images series in Figure 12, it becomes clear how immobile the conventional dummy is in comparison to the biofidelic dummy. The absent deformation behaviour of the NAMI-dummy means that the main force exchange is not on the top side of the bonnet but instead on the front edge. Thus, a head impact does not occur on the upper side of the bonnet. Rather, the rigid construction of the NAMI-dummy shows that it rotates on to its back during the collision and is therefore repulsed laterally from the vehicle after the main force exchange. An undergoing also does not occur, since the dummy takes on the speed of the SUV significantly quickly.

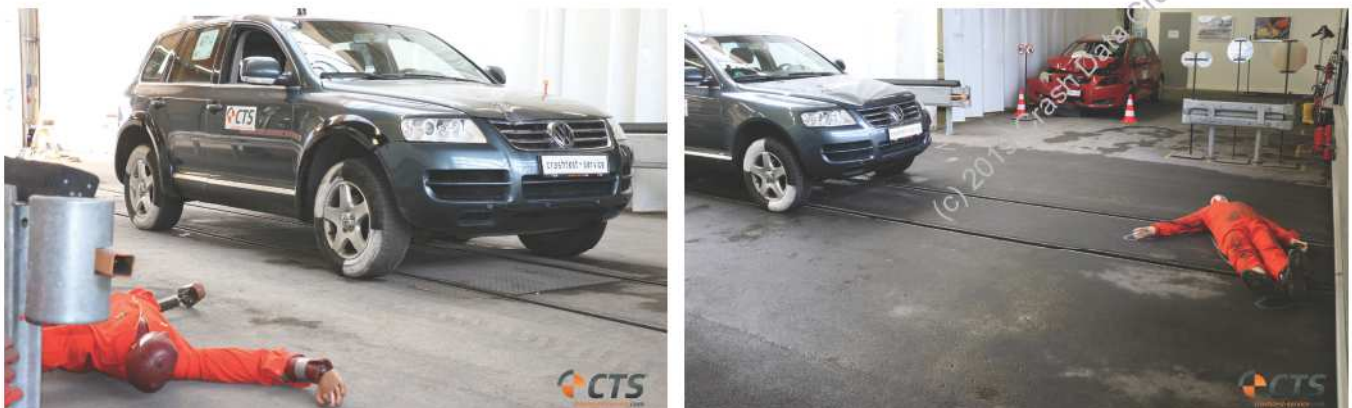
Figure 13: End positions of the different dummy types

The end positions of the different dummy types reflect the significant deviation in the movement behaviour. Whilst the biofidelic dummy comes to rest after approximately 18 m almost straight in front of the SUV (Figure 13, right image), the NAMI-dummy rolled off the bonnet to the right during the collision due to the lack of deformation behaviour and reached a longitudinal throwing distance of only 14 m with a lateral offset of 2.5 m from the collision position (Figure 13, left image).

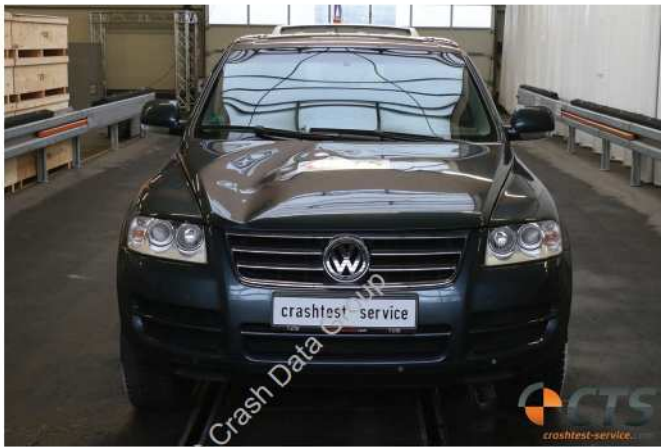
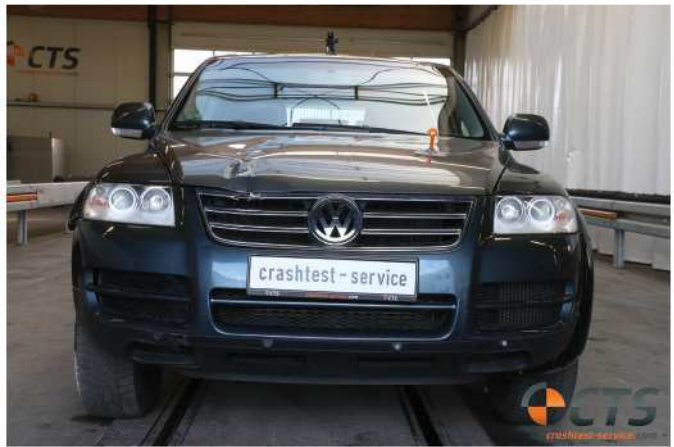
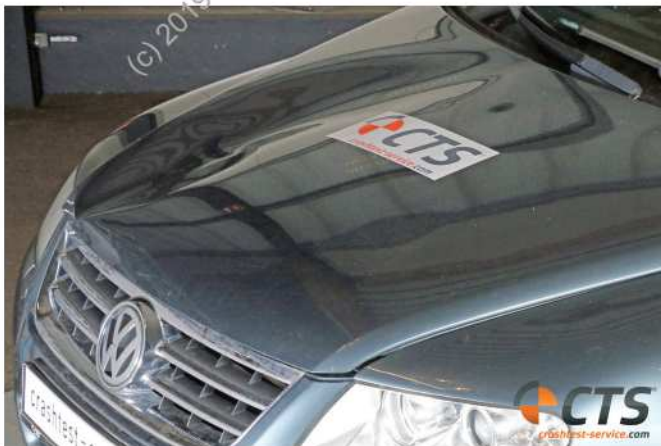
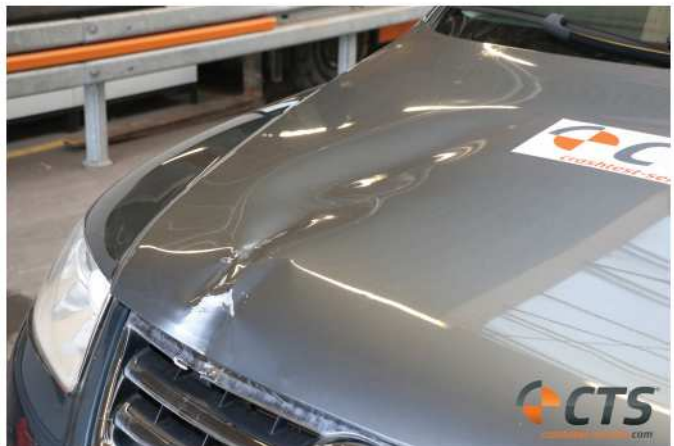
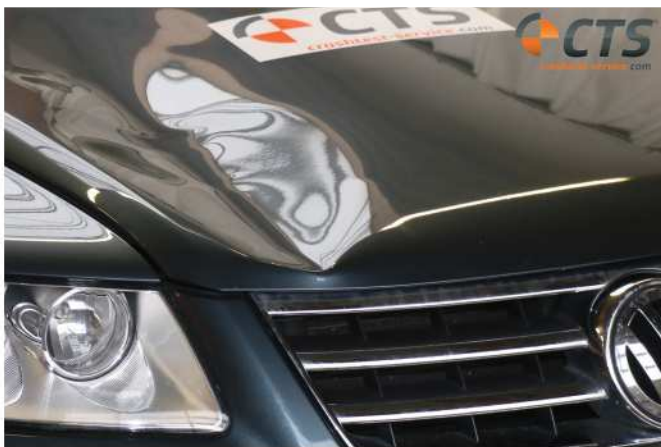
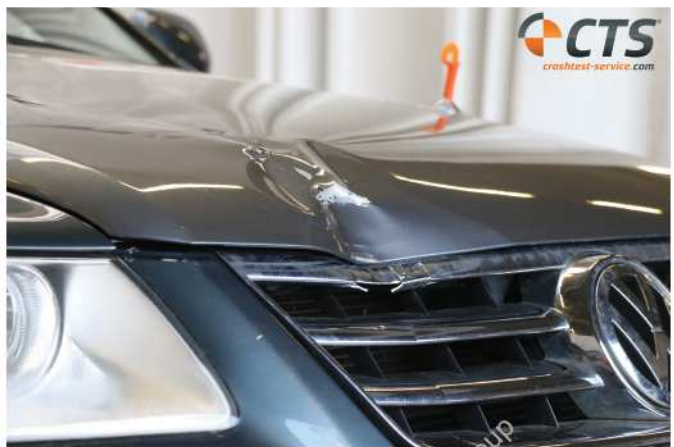
Figures 14-16: Vehicle damages to the VW Touareg

The comparison of the vehicle damages on the VW Touareg in both crash tests are shown in Figures 14 to 16. It becomes clear that the SUV during the crash with the biofidelic dummy has a deep extensive indent in the bonnet, which results on the bonnet from the impact of the upper body and the top of the head. The force exchange takes place essentially from the top. At the point of impact with the NAMI-dummy the bonnet was impacted from the front so that the bonnet at the first contact was significantly compressed backwards and the paintwork partially flaked. Additionally, the front grill and the bumper covering underneath the right headlight have been damaged by the impact with the NAMI-dummy, which do not occur when impacting the biofidelic dummy.

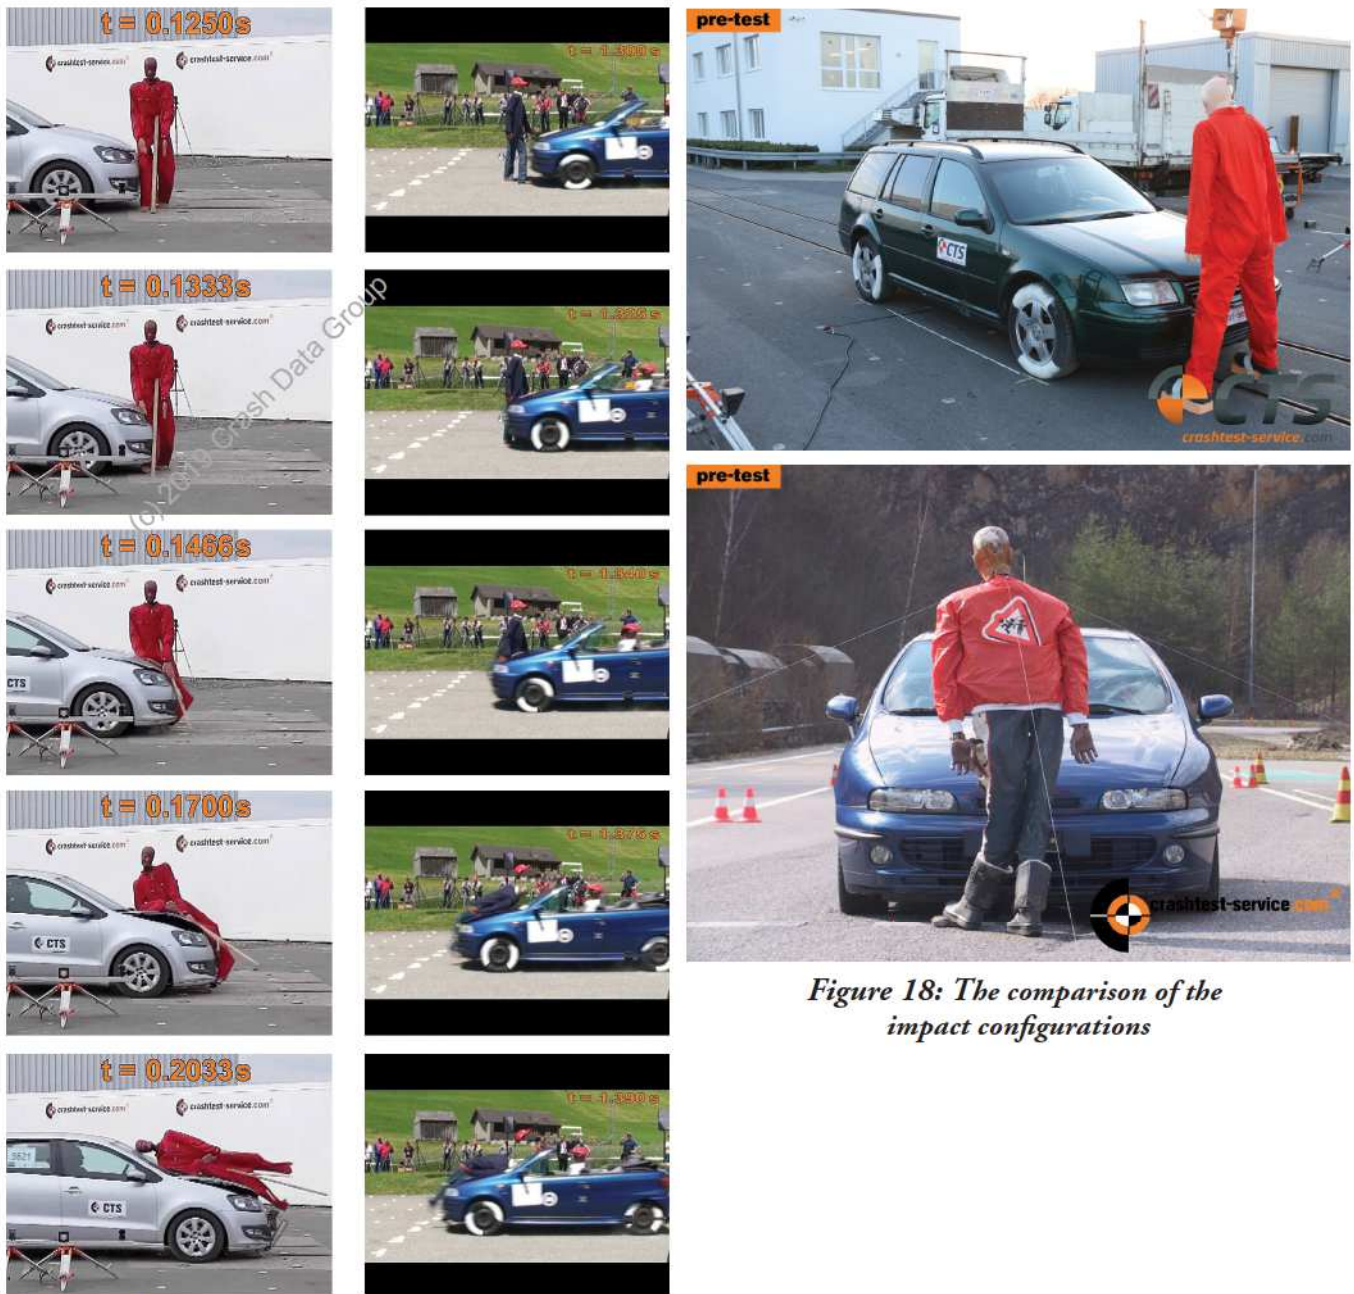
Figure 18: The comparison of the impact configurations

Figure 17: Carrying-characteristic of the pedestrian

As shown in the comparison in the series of images in Figure 17 the carrying-characteristic of the pedestrian is dependant on the impact direction. A lateral impact impedes the bending movement of the upper body, a head-on impact causes the pedestrian to bend like a folding knife on the vehicles front, the forwards bending of the upper body is unrestrictedly possible.

So far there are only very few crash tests in order to judge the vehicle damages during a head-on impact with a pedestrian. For the purpose of the preparing an accident reconstruction expert report, a crash test at CTS was commissioned, where a biofidelic dummy should be impacted head on at a speed of almost 60 kph. The test vehicle used was a VW Bora. In order to also be able to make a comparison in head-on collisions between a biofidelic and a conventional dummy a crash test with a Fiat Bravo from the CTS-database was also used, where a conventional dummy was impacted head-on at the same velocity. The comparison of the impact configurations is presented in Figure 18.

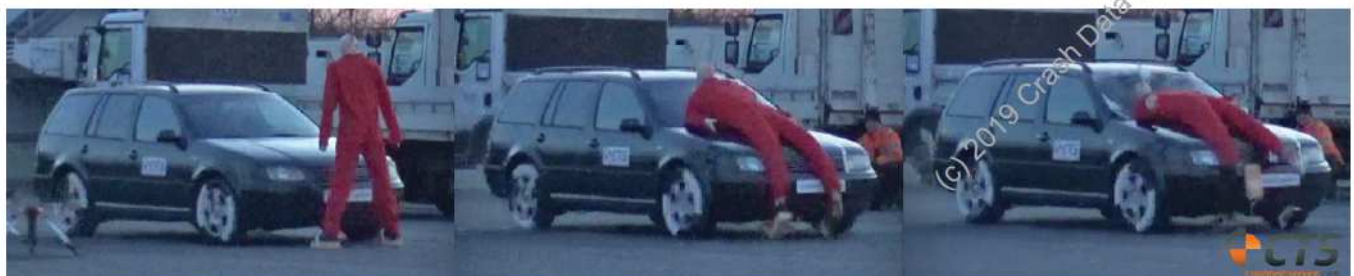
Figure 19: The movement sequence of the biofidelic dummy in a head-on crash impact configurations

The movement sequence of the biofidelic dummy in a head-on crash is indicated in Figure 19. The upper body tilts forwards whilst the legs are initially pulled under the car and then thrown back (from the perspective of the pedestrian) by the vehicles front. At the collision speed of the VW Bora at 62 kph the dummy does not hit the bonnet, which is the case when laterally impacted and the collision-related rolling off, but rather hits the front windscreen of the test vehicle directly with the head.

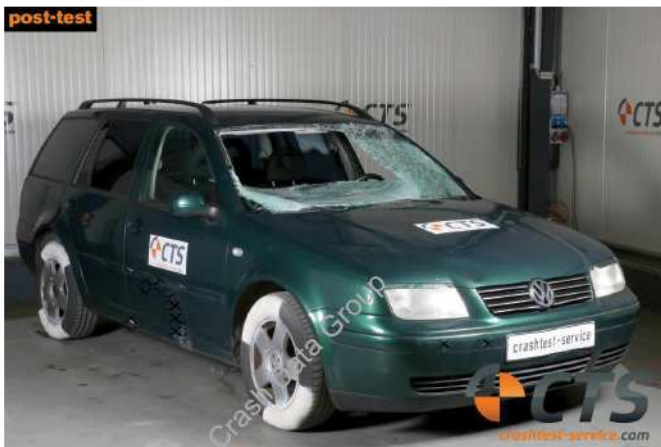
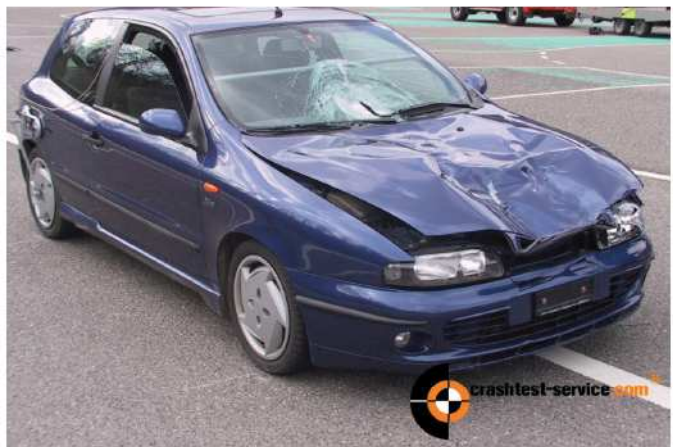
Figure 20: The comparison of the vehicle damages

The comparison of the vehicle damages is shown in Figure 20. The bonnet of the Fiat Bravo is severely deformed and raised, since the rigid Winterthur-dummy¹ pushes the bonnet back and inwards at the point of contact. A similar behaviour shown by the NAMI-dummy due to its immobility when laterally impacted by a VW Touareg.

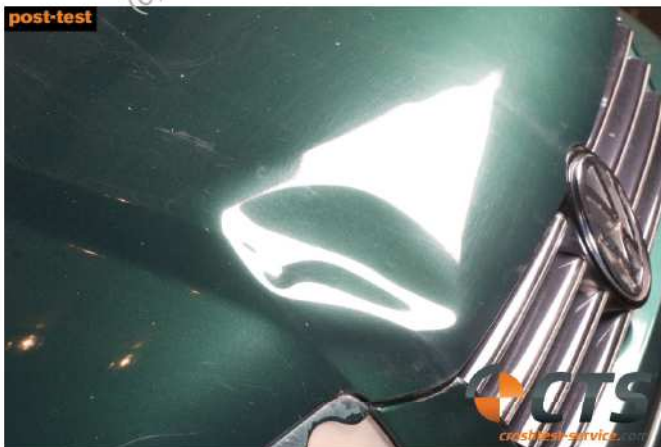
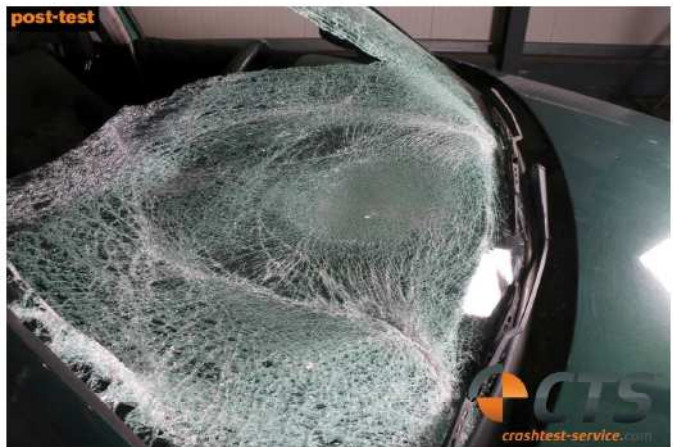
Figure 21: The bonnet of the VW Bora

Besides the dent in the front edge of the bonnet which can be attributed to the knee impact of the biofidelic dummy, the bonnet of the VW Bora at the same collision speed was not damaged, Figure 21. The fracture caused by the impact of the head is situated at roughly the same height as on the Fiat Bravo and shows a lower intensity. The fact that the front windscreen of the VW Bora came around two thirds loose from the frame and was pushed inwards it is possible that it is not solely due to the high collision speed of 62 kph. Since the original windscreen of the VW Bora was

slightly cracked before the crash test, it was replaced two days prior to the test. The unusual fracture pattern at the edges of the front windscreen is eventually due to the prior exchanging of the windscreen so that only the damages to the bonnet can be used to compare the crash behaviour of the biofidelic and conventional dummies. The unexpected minimal damages caused to the bonnet of the VW Bora in contrast to the severely deformed bonnet of the Fiat Bravo at the same velocity level rises the question whether in the past the collision speed of the accident vehicle in head-on

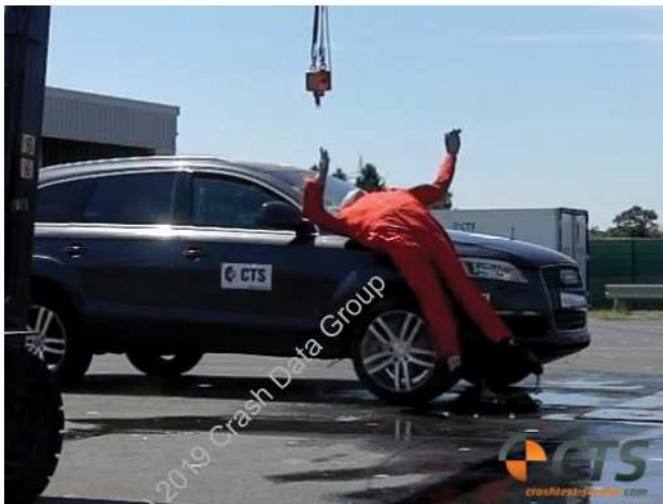
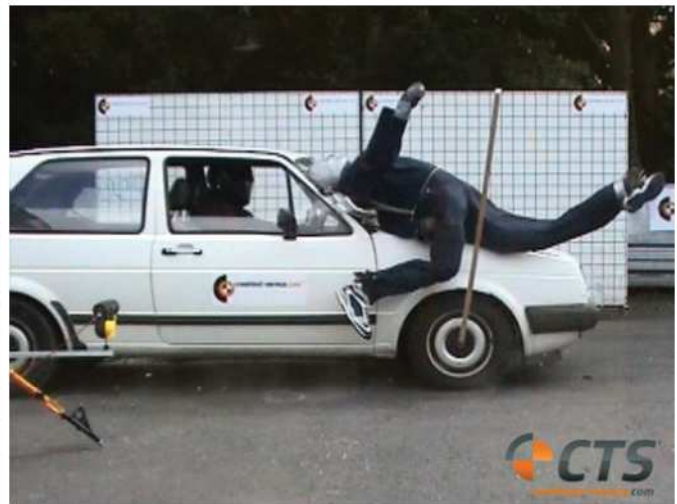
Figure 22: Collision between Audi Q7 and VW Golf III with a biofidelic dummy

Figure 22 shows hereby a crash comparison of a biofidelic dummy and a conventional dummy in a grazing impact by which it came to an impact with the head on the front windshield and subsequently a contact with the A-pillar. On the left of Figure 22 shows a collision of an Audi Q7 at 57 kph with a biofidelic dummy. The right image shows a test by which a VW Golf III grazes a Hybrid-I dummy at 62 kph. The damage pattern comparison can be seen in Figure 23, which shows in both tests a significant damage to the front windscreen in the form of a fracture. The damage to the A-pillar fundamentally differentiates due to the vehicles and in particular the movement behaviour of the dummy.

Due to the mobility of the biofidelic dummy it hits the front windshield with the head in a nodding-movement and rolls then, initiated by the previous grazing impulse, over the A-pillar and the wing mirror. Due to the movement and therefore the change in contact points the A-

pillar of the Audi does not appear to be deformed. In a collision with the VW Golf III, the dummy tilts over on to the vehicle. Because of the hard construction, the A-pillar is massively deformed.

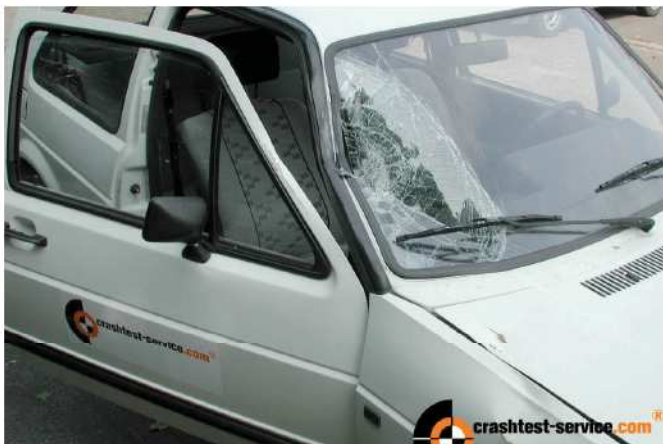
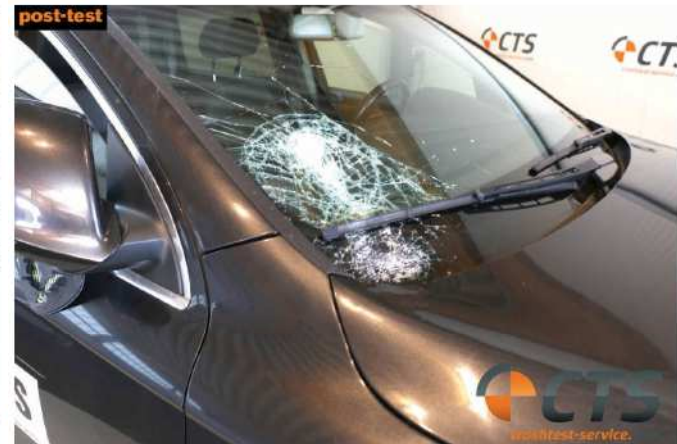
Figure 23: Damage pattern comparison

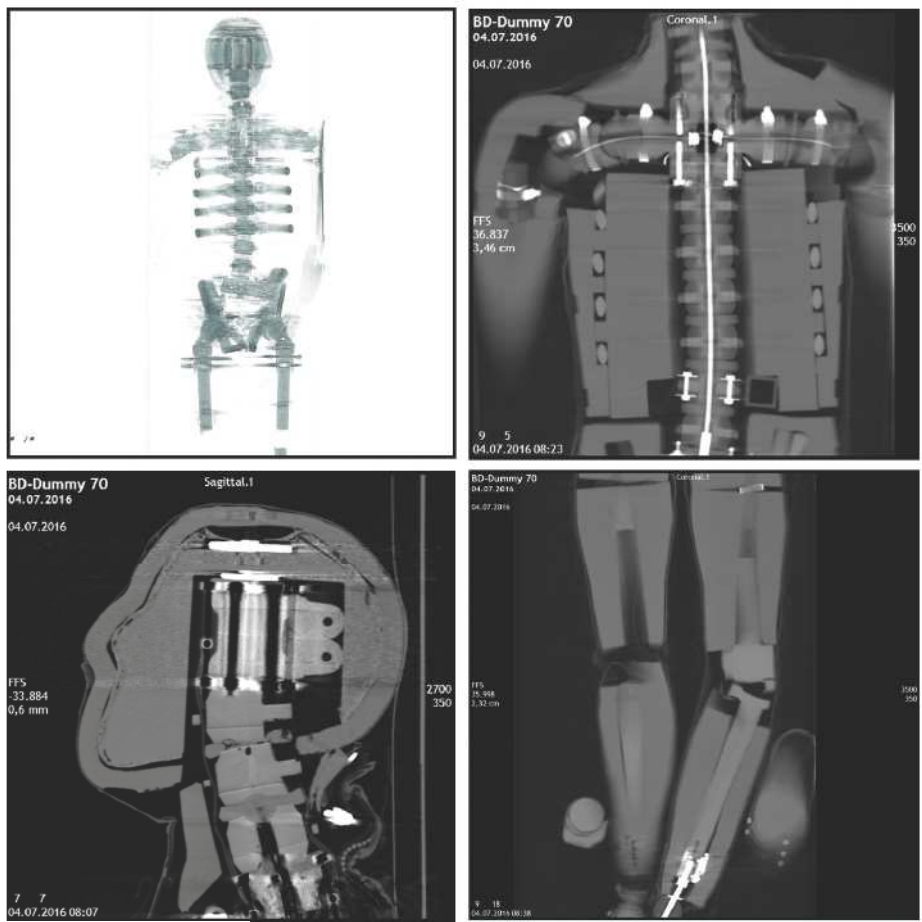
Figure 24: CT-scan of the predecessor model of the biofidelic dummy

fractures or breaks resulting from the crash test. This principal is presented in Figure 24 in form of a CT-scan of the predecessor model of the biofidelic dummy. In this case, the collision velocity at impact with the dummy was approximately 70 kph. The x-ray examination can be carried out after the crash test in cooperation with the veterinary clinic in Telgte, who obtained an official authorisation from the district government for undertaking such examinations. If required, an autopsy of the biofidelic dummy can also be done after the collision, an example is shown in the images of Figure 25. After carrying out crash tests for the reconstruction of passenger car-pedestrian accidents, it is possible for the biofidelic dummy to be repaired by CTS, so that the cost of the dummy for the crash test is only limited to the rental fee and therefore the dummy must not be completely charged for.

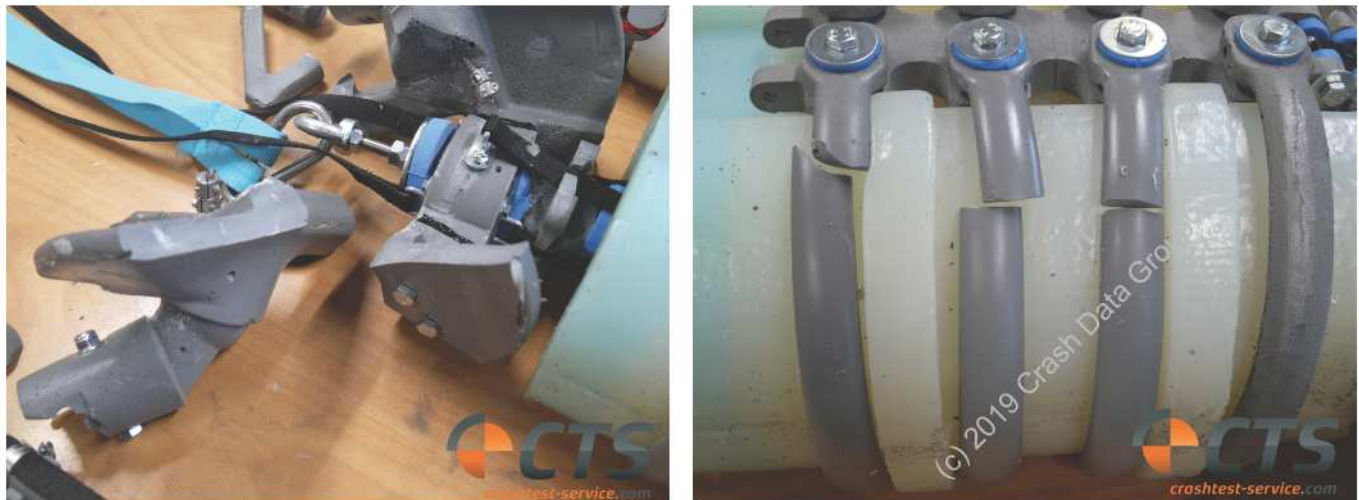
Figure 25: An autopsy of the biofidelic dummy after a collision
