# Collision

# VEHICLE DAMAGES AND LONGITUDINAL THROWING DISTANCES WHEN USING BIOFIDELIC DUMMIES IN COMPARISON TO CONVENTIONAL DUMMIES

ANNIKA KORTMANN AND TIM HOGER

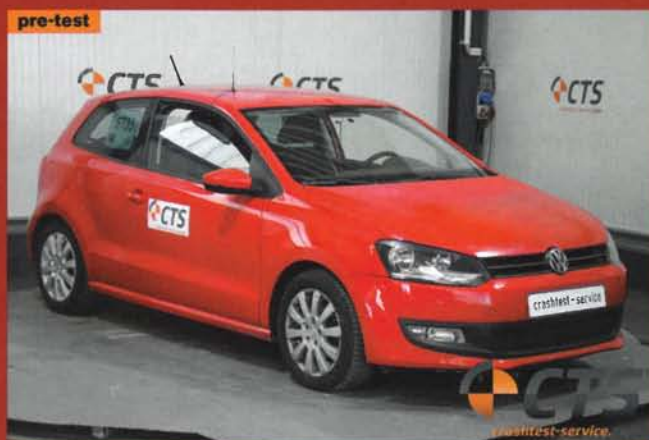
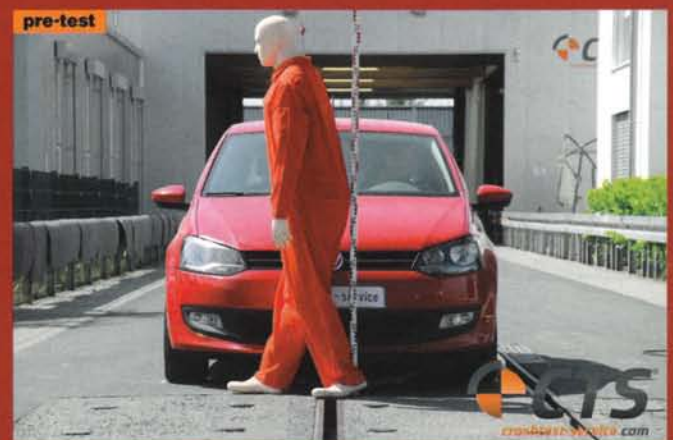
Figure 1: Crash test vehicle VW Polo 6R (left) and impact situation with a biofidelic dummy (right) for the crash series performed

A crash test series at different velocities was carried out, creating a form of EES-catalogue. The crash vehicles were several VW Polo 6R. The biofidelic dummies were laterally approached in most tests and impacted at the centre of the

bonnet by the car, figure 1. The VW Polo was not braked during the collision and was decelerated after a defined short period of time, which was almost the same in all crash tests, to prevent “carrying” with a subsequent transport phase. The controlling, that it did not come to a carrying phase, was done over the videos. The collision speeds in the crash tests were (rounded off) 28 kph, 47 kph, 68 kph and 80 kph. In all tests, the damages and the dummy throwing distance was documented in detail. The new crash series with the biofidelic dummies build on the already existing crash test series carried out by crashtest-service.com GmbH, in which a VW Polo 6R was driven under the previously described impact constellation in six tests against a conventional dummy.<sup>4</sup>

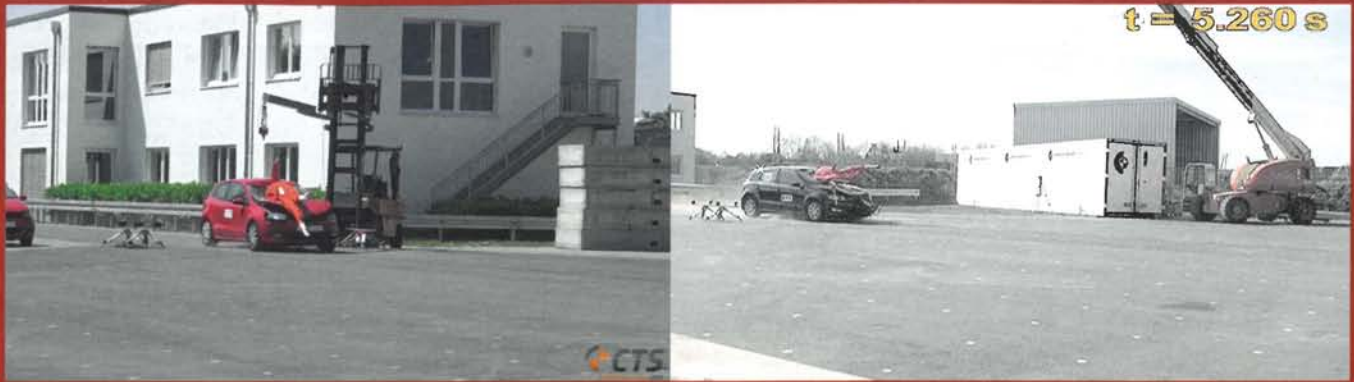
**Figure 2: Re-enactment (left – biofidelic) of the already available crash tests (right – conventional) – collision velocity here:  $v = 68$  kph**

In the velocity range between 70 kph and 80 kph, the already existing crash tests were carried out again under the same conditions but with the biofidelic dummy, figure 2. Thus, the study not only offers the possibility to investigate the increase in vehicle damage and longitudinal throwing distance with increasing collision speed, but also to make a direct comparison between the biofidelic and conventional dummy.

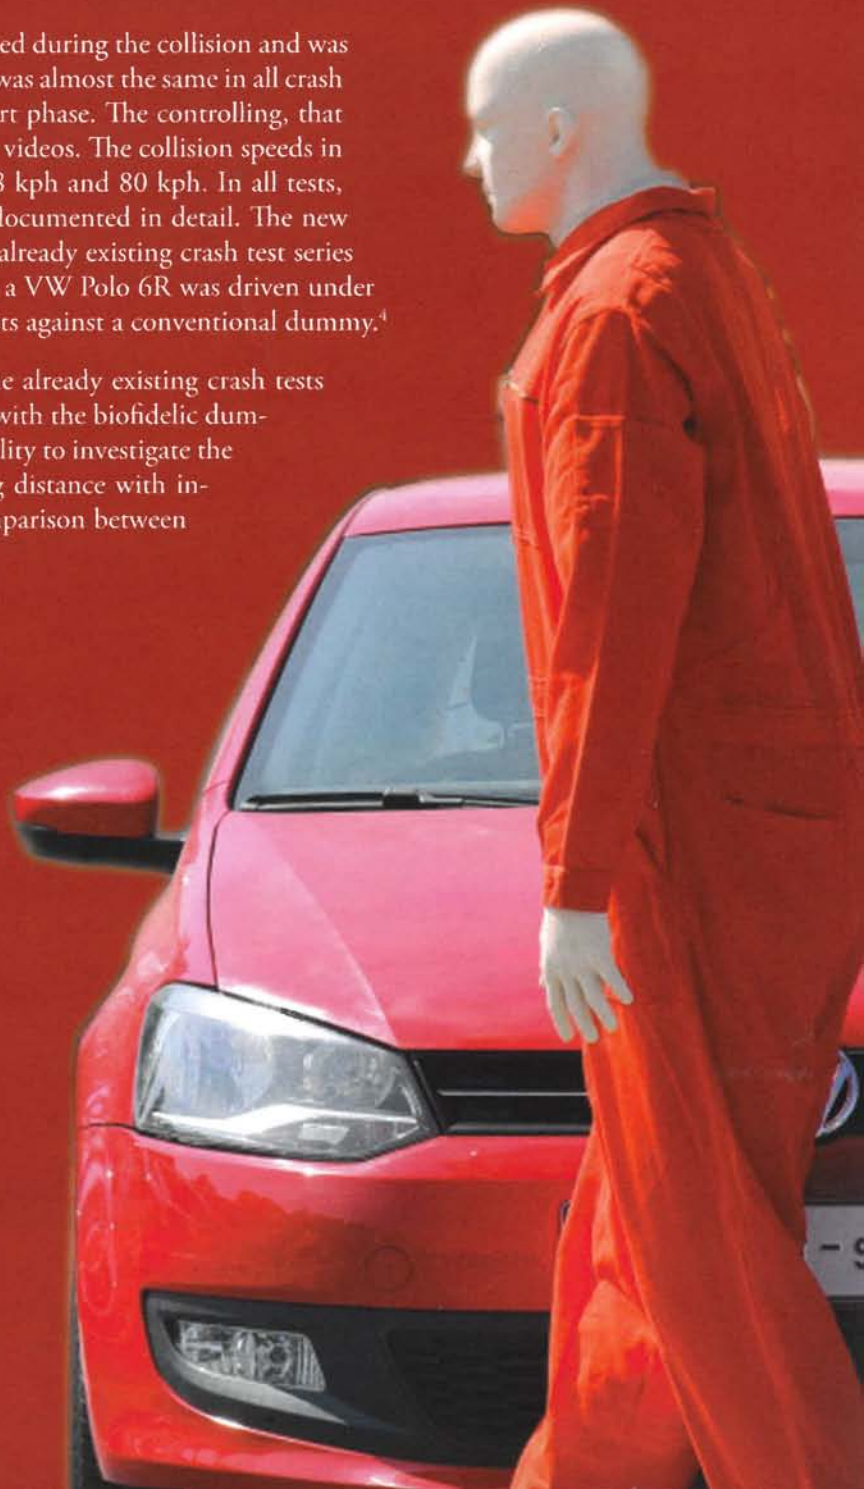
*Figure 3: Frontal and side view of the change in the damage pattern (impact with biofidelic dummy) on the VW Polo 6R with increasing collision velocity from 27.5 to 80.2 kph*

Figure 3 documents the resulting damages incurred at increasing collision velocities in the range between 28 and 80 kph in a collision with a biofidelic dummy.

The collapsing of the front windshield at a collision speed of 46.7 kph results from the predamage occurring in the first crash attempt at 27.5 kph, which was not replaced after the crash test.

Taking into account the damages of the front windshield in the two following crash attempts, it can be assumed that also at a collision speed of approximately 50 kph the front windscreen would not have been penetrated. As the collision velocity increases, the damage to the bonnet and the windscreen also increase. By increasing the collision velocity,

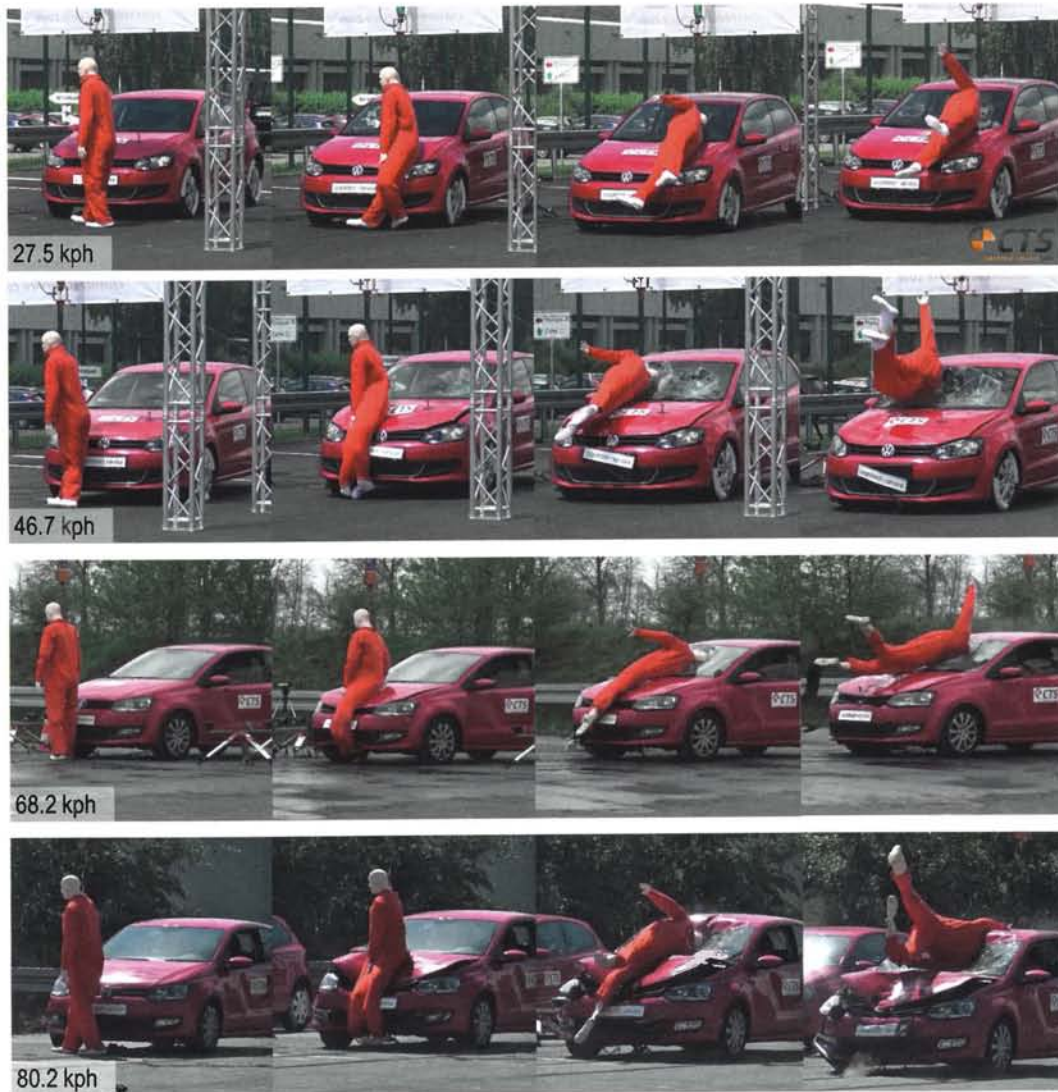
**Figure 4: Motion sequence of the biofidelic dummy and head impact height with increasing collision velocity**

the head impact of the dummy also moves towards the edge of the roof. This is shown in the comparison of the motion sequences of each individual crash attempt in figure 4. At a collision speed of approximately 70 kph, for the first time the head of the biofidelic dummy contacts the front roof edge. A significant damage to the roof occurs at a collision velocity of approximately 80 kph. At this collision speed, the bonnet of the vehicle is clearly crumpled.

The crumpling of the bonnet of the VW Polo at a collision speed of 80 kph is a result of the wrap-around movement of the biofidelic dummy (comparison of motion sequences in figure 4). Due to the rigid construction of the conventional dummy, the dummy rotates around its centre of gravity and collides then almost horizontally with the front windscreen. The bonnet remains mostly contact-free so that fewer damages to the bonnet occur (figure 5 and fig-

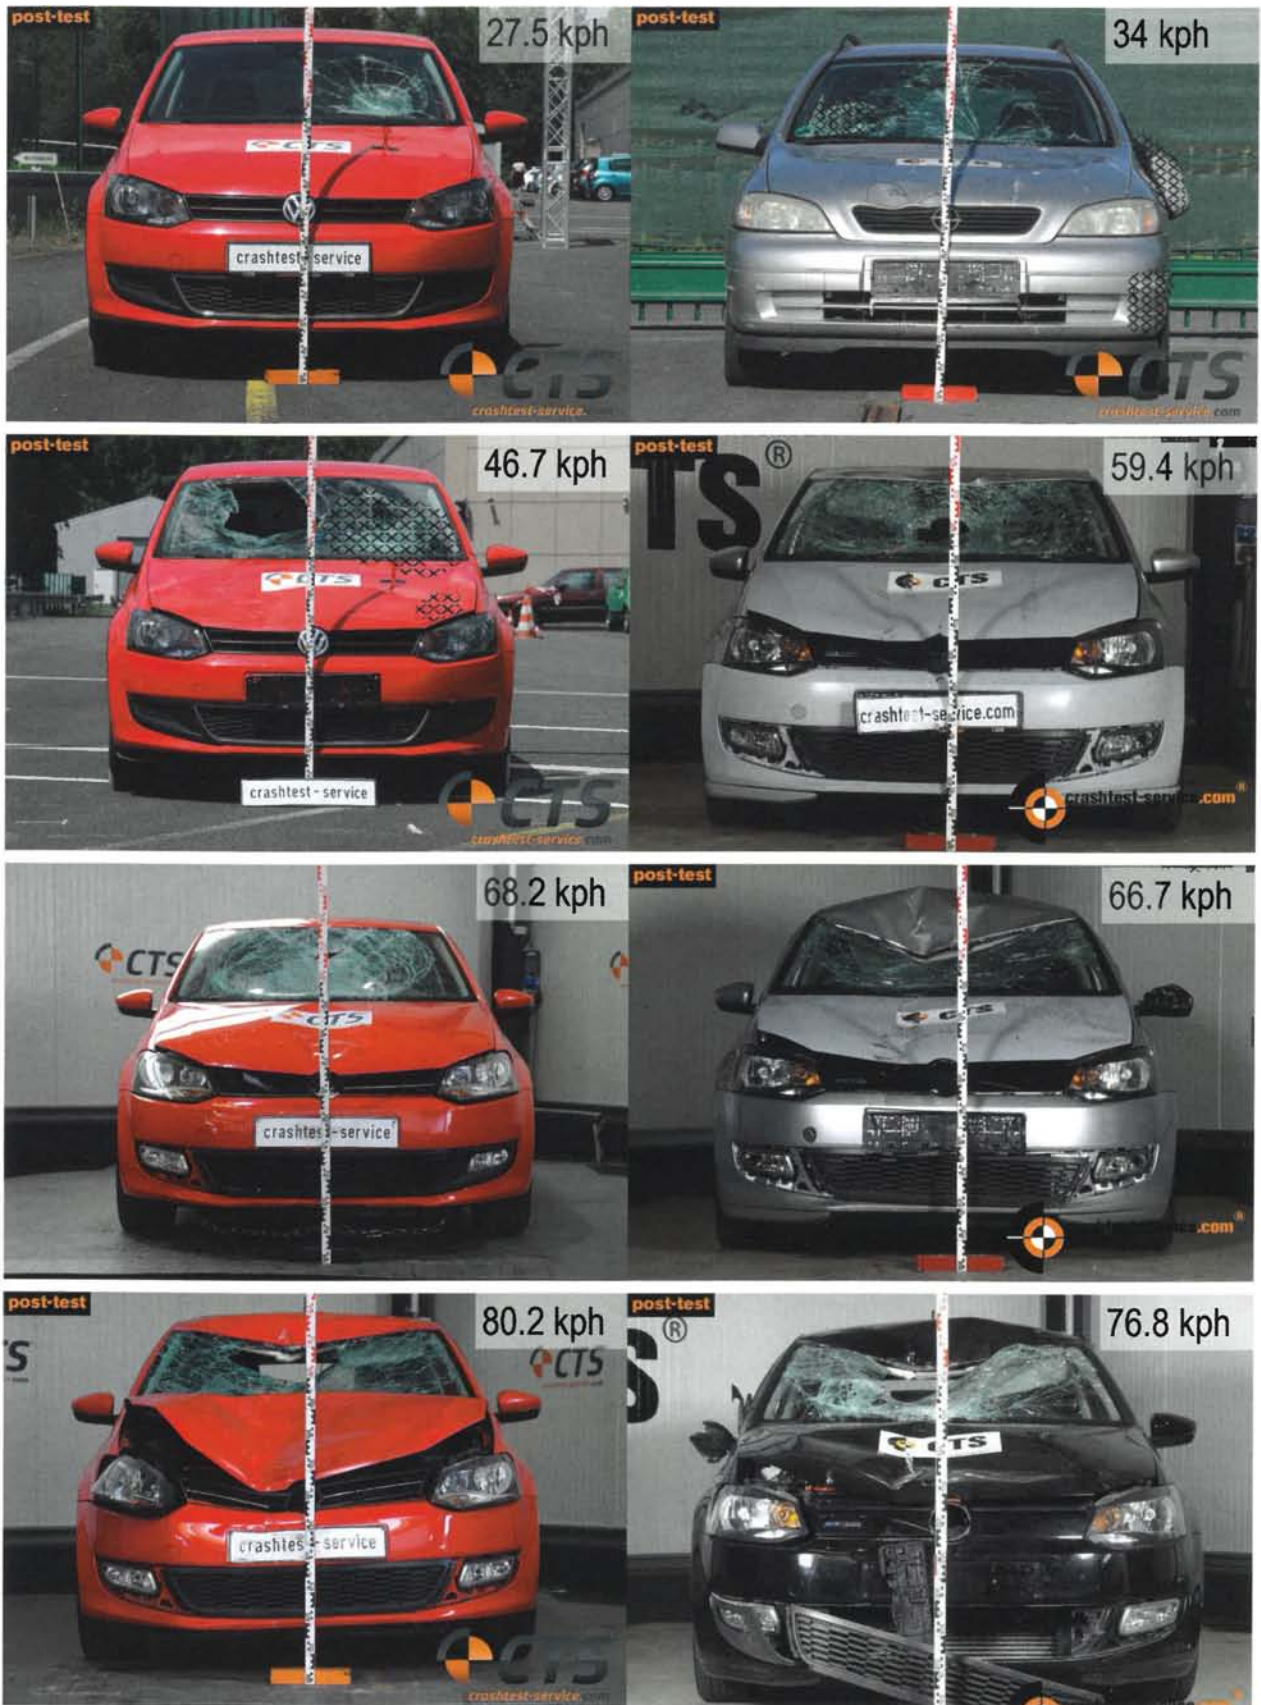
**Figure 5: Comparison of the damage to the VW Polo 6R after an impact with the biofidelic dummy (left) and a conventional dummy (right) with increasing collision velocity (frontal view)**

In figure 5 and figure 6 the damages of the crash vehicles at comparable collision velocities in the front and side view after an impact with a biofidelic (left) and a conventional dummy (right) are directly compared with each other. It

should be noted that the crash attempt with the biofidelic dummy at a collision velocity of around 50 kph was approximately 13 kph slower (46.7 kph biofidelic dummy, 59.4 kph conventional dummy).

From the damage comparison between the biofidelic and conventional dummy impact in the lower speed range, it is apparent that the impact of the biofidelic dummy produces a defined crack in the windscreen, with a deeper pushed in centre but a smaller extension. The scratch marks and the slight deformation of the bonnet of the Opel (conventional dummy) does not occur to the VW Polo (biofidelic dummy). This can be explained by the wrap around behaviour of the biofidelic dummy in contrast to the rigid physique of the conventional dummy, as earlier studies have also demonstrated.<sup>5</sup>

ure 6, bottom right images) in comparison to the impact with a biofidelic dummy colliding at the same velocity.

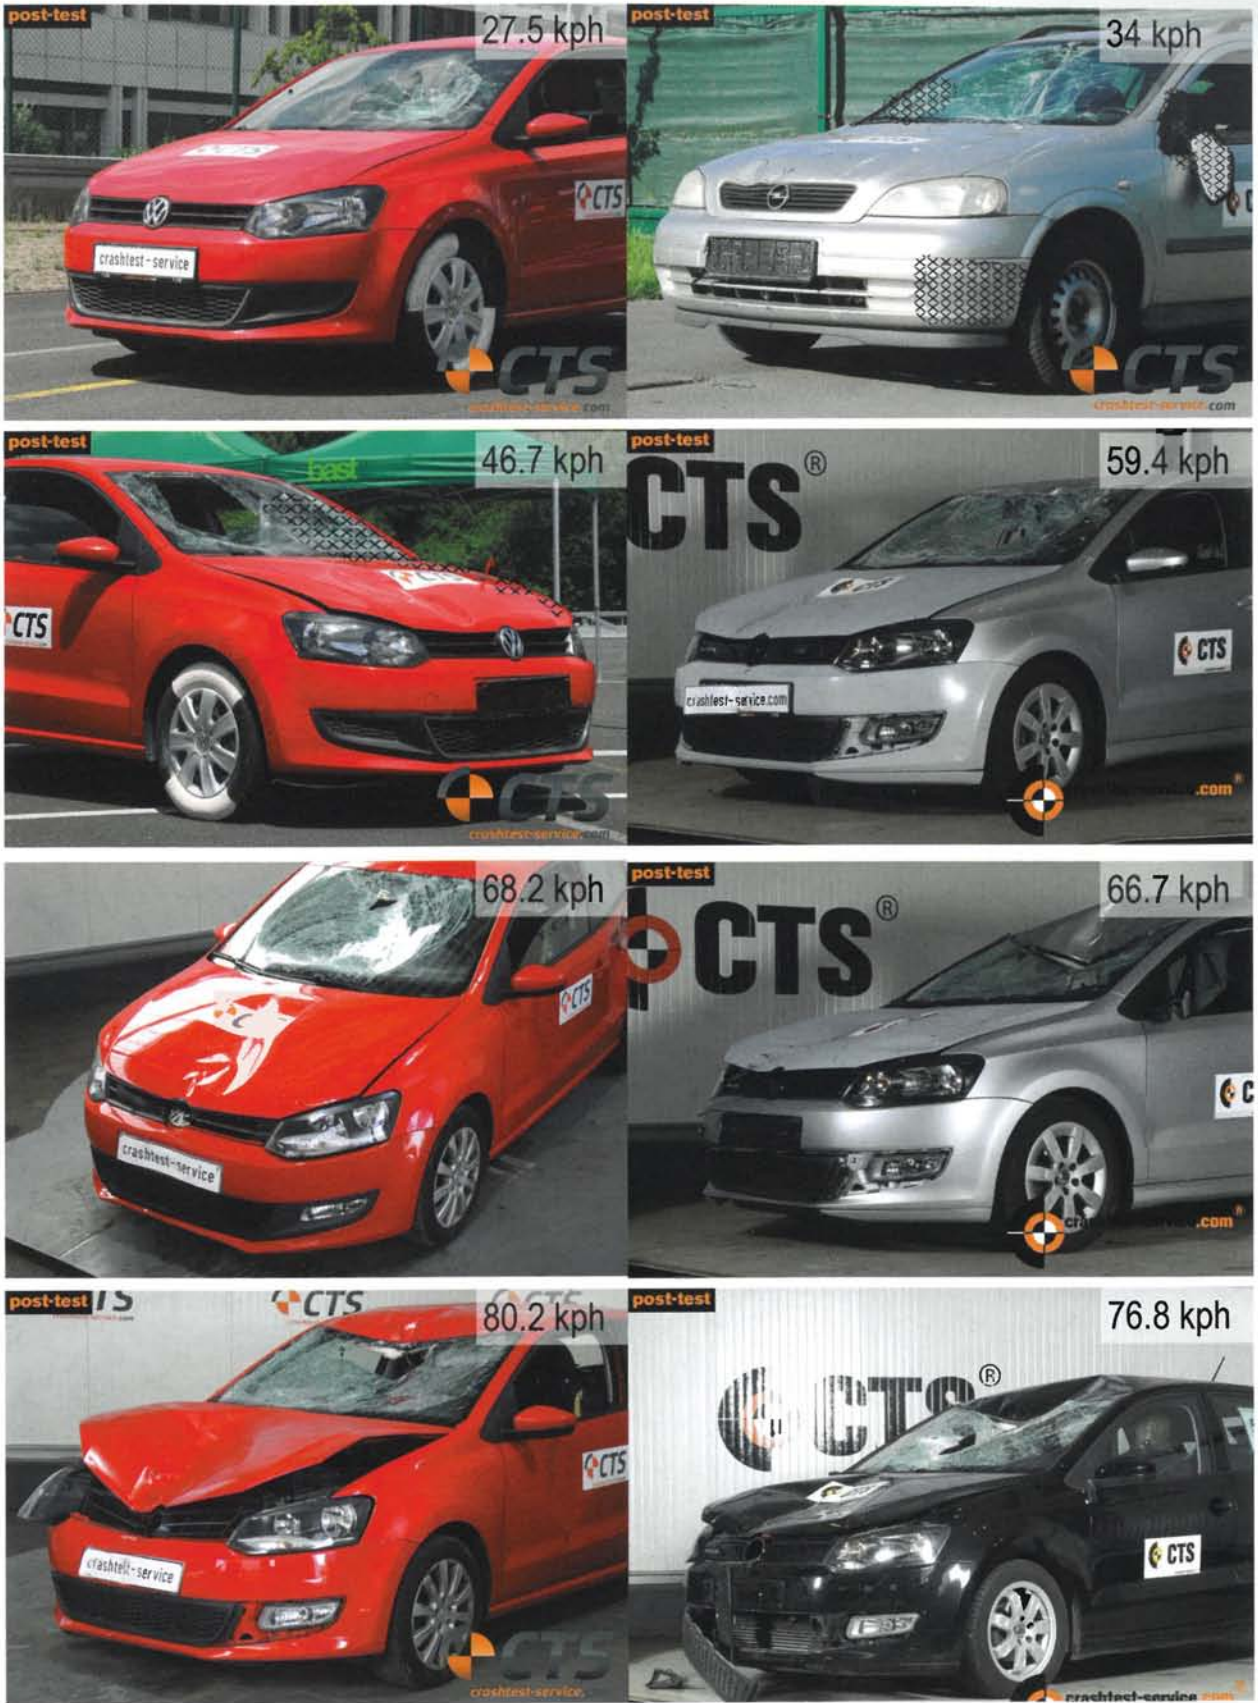
**Figure 6: Comparison of the damage to the VW Polo 6R after an impact with the biofidelic dummy (left) and a conventional dummy (right) with increasing collision velocity (side view)**

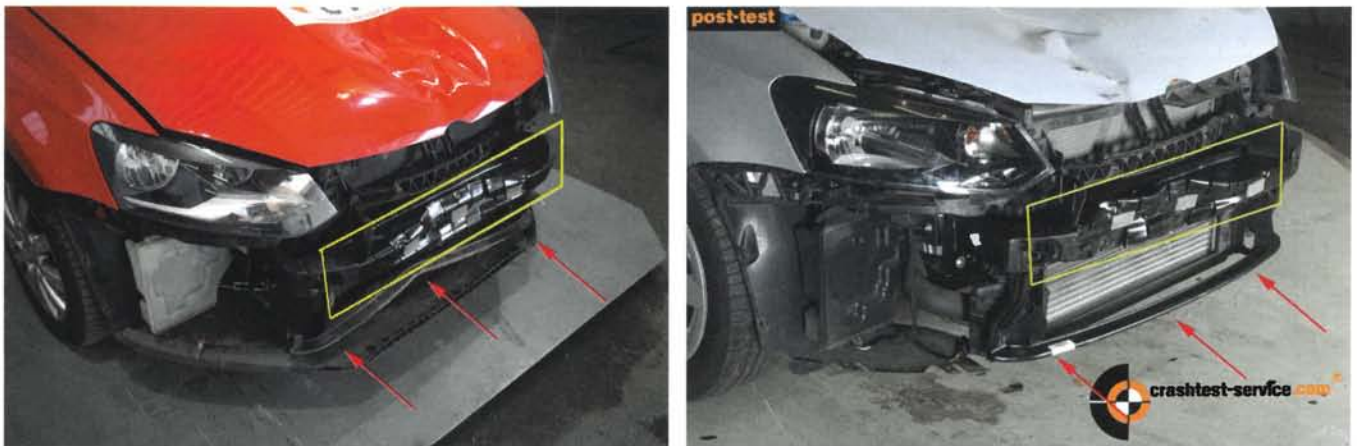
**Figure 7: Comparison of the frontal damage to the crash vehicle (bumper removed) after a collision with the biofidelic dummy (left) and a conventional dummy (right) at  $v = 70$  kph**

Upon closer examination of the black VW Polo (impact against a conventional dummy) it presents more front damages. Due to the rebounding of the bumper covering after the collision, the high deformation of the crossmember is only apparent after disassembling the bumper cover. Figure 7 shows an example of the front damages to the crash vehicle with a disassembled bumper cover from a collision at approximately 70 kph. It can be seen, that the crossmember of the VW during the impact against a conventional dummy (figure 7, right image, yellow framed) was more severely dented than in a collision against a biofidelic dummy (figure 7, left image, yellow framed). From the deformation of the front crossmember of the VW Polo in an impact with a conventional dummy, even the stride

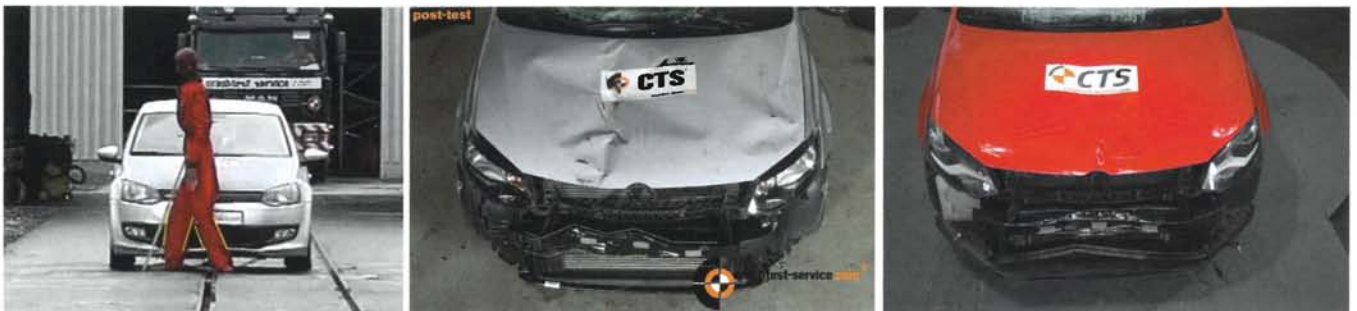
**Figure 8: Step position for the impact with the conventional dummy (left) and the resulting cross-member deformation (centre) at  $v = 70$  kph; comparison of the frontal damage after an impact with the biofidelic dummy (right)**

position of the dummy at the point of the collision can be detected, see left and middle image in figure 8. This results from the structurally rigid construction of the conventional dummy, which at this point hits the leg area. Since the feet are not pulled under in a collision with a conventional dummy, the front pedestrian under-run protection in the form of a bracket sitting just above the underbody remains completely intact (red arrows), whereas this bracket in a collision with a biofidelic dummy is severely pressed inwards, and therefore fulfilling its function (see also right image in figure 8).

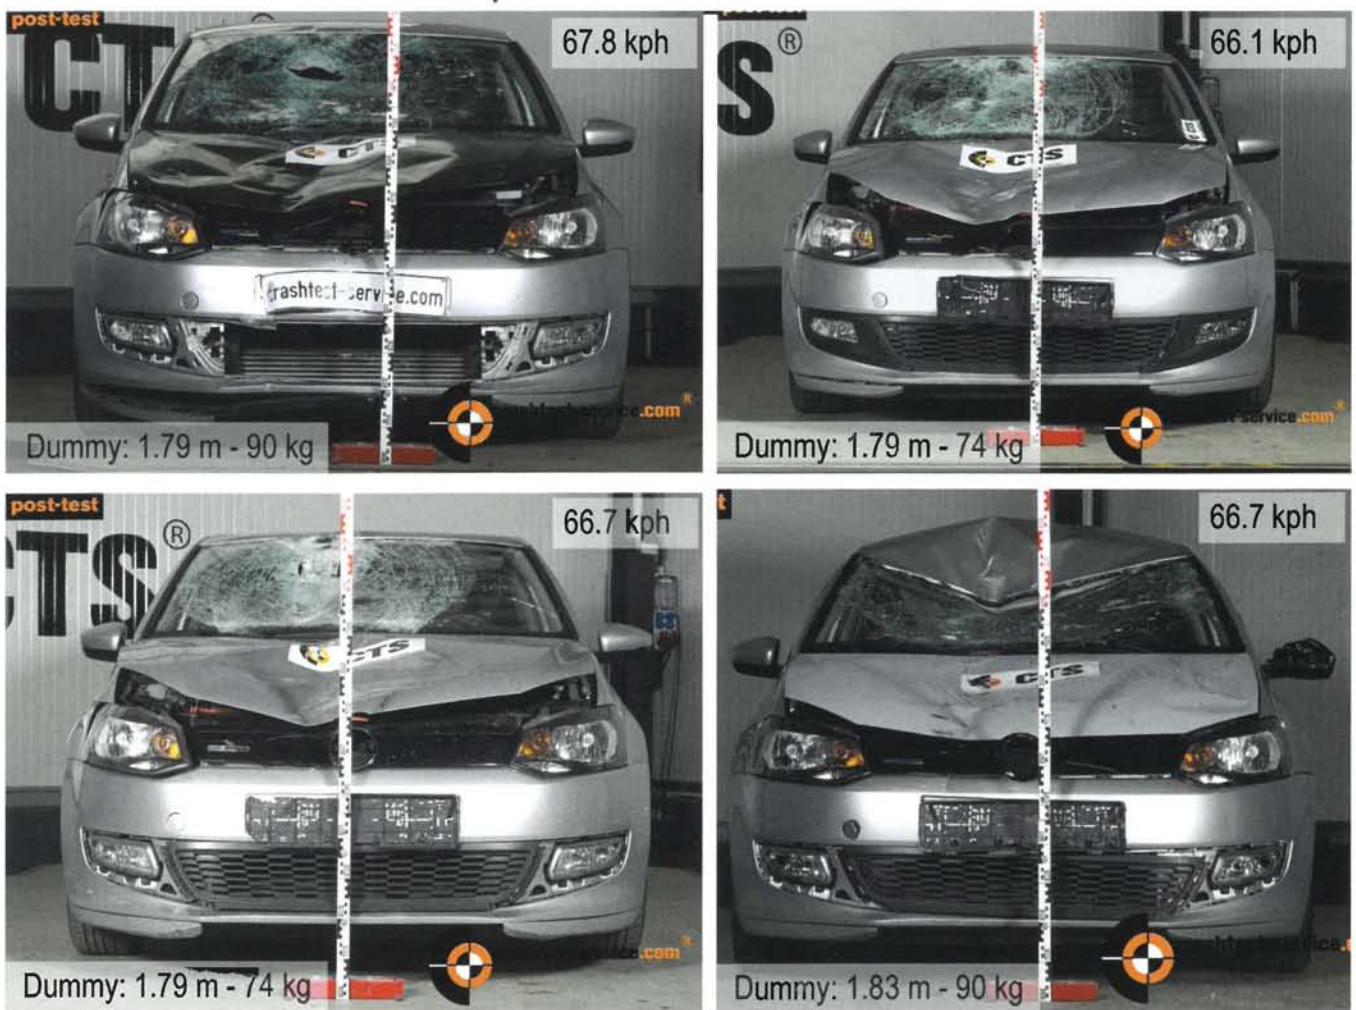
**Figure 9: Comparison of the damage to the VW Polo 6R after an impact with a conventional dummy in the velocity range from 66 to 68 kph**

How susceptible the damage input on a vehicle in passenger car-pedestrian collisions with conventional dummies is, is shown in the compilation of damage pictures of the crash vehicles accordingly in figure 9.

The impact constellation (laterally approached, centre of the bonnet) and the collision velocity (66 to 68 kph) were almost identical in all the crash test attempts shown. Only the weight and the height of the conventional dummies varied slightly. It emerges that the influence of the weight between 74 and 90 kg has no clearly visible changes in the vehicle damages occurred to the presented crash vehicles. A change in height from 1.79 m to 1.83 m, however, leads to a completely different damage pattern, as with in this

crash test the roof edge of the vehicle was hit and massively compressed.

The energy absorption of the vehicle must be similar in all four crash test attempts. Three of the four attempts show very similar damages to the bonnet and the windshield. The energy was mainly absorbed by the windscreen, bonnet and the front crossmember. The Windscreen has even been partially pierced by the conventional dummy. The slightly larger dummy in the fourth crash test (figure 9 bottom right image) results in a higher contact point of the dummies head on the vehicle.

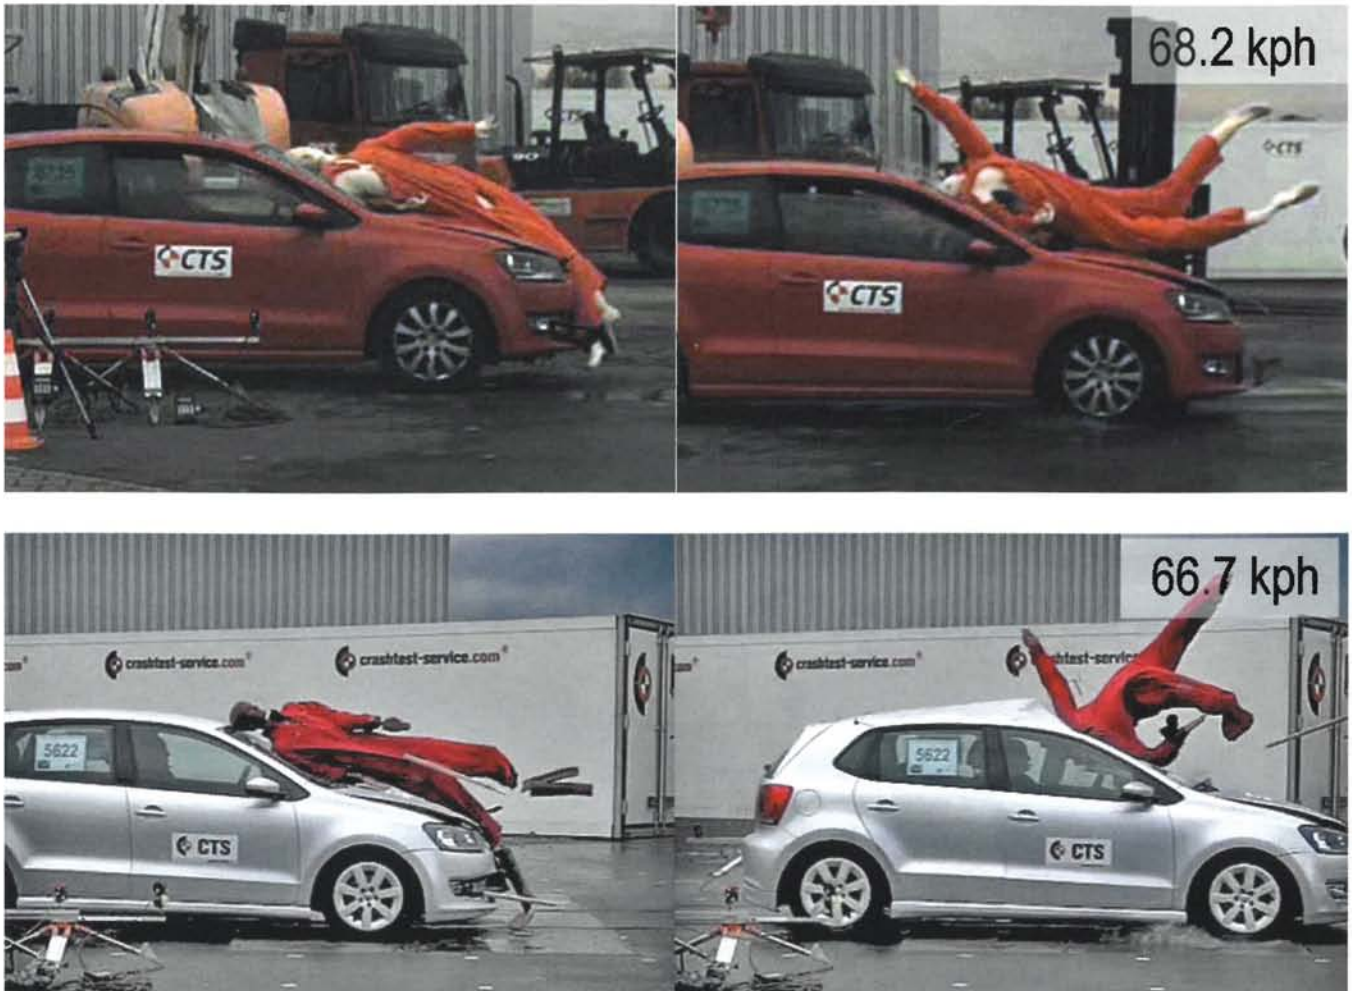
Figure 10: Deformation of the roof edge after an impact with the biofidelic dummy (top) and a conventional dummy (bottom) at approx. 70 kph

The dummy strikes almost horizontally against the roof edge, figure 10 bottom images, so that the energy absorption mainly takes place through the compression of the roof. Simultaneously, in this position the conventional dummy has an unnaturally rigid structure. In the collision with the biofidelic dummy (figure 10 top images), the described wrap around behaviour occurs, so that the energy

absorption by the vehicle can evenly be distributed over the contact surfaces between the vehicle and the dummy.

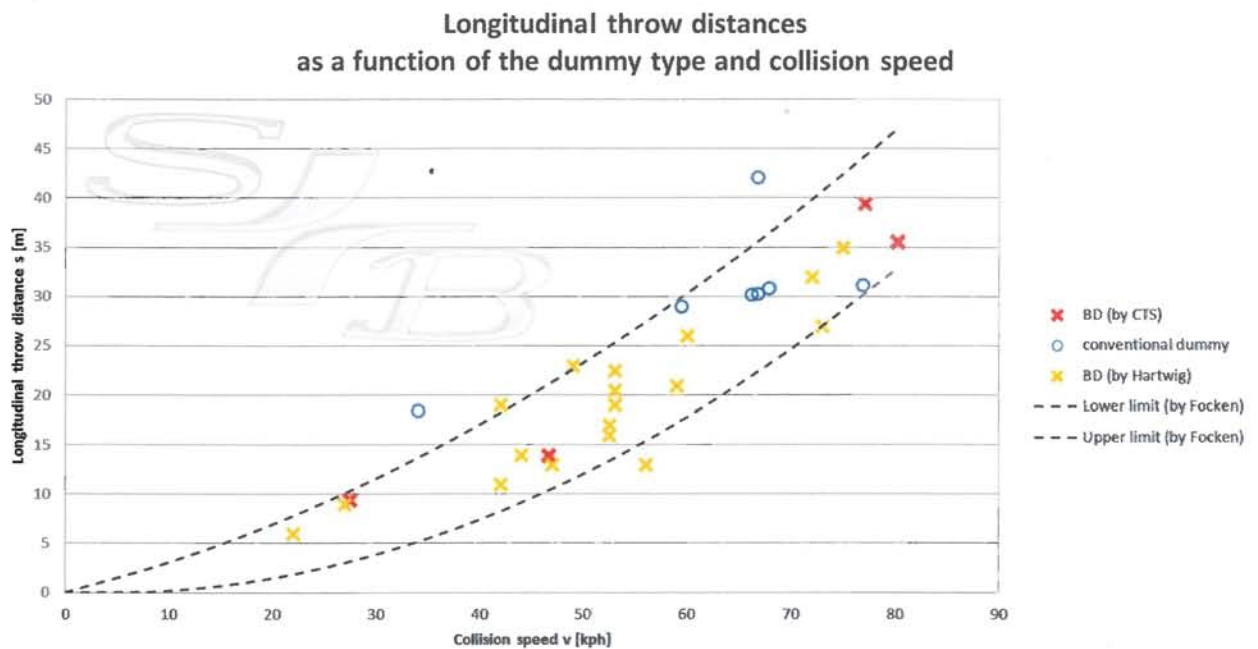
Figure 11: Graph with throw distances of the different dummy types as a function of the collision velocity – trend line according to Focken<sup>6</sup>

The longitudinal throwing distances determined from the investigated crash test attempts are listed in table 2 and have been recorded in a graph, see figure 11. In the case of specifics present in the crash tests, this has been noted in table 2. Likewise, the throwing distances from the investigations of Hartwig et. al.<sup>2</sup> were also added to the graph.

major differences in the damages, there is no deviating trend determined in the longitudinal throwing distance of the biofidelic dummy compared to the conventional dummy. This is also shown by the added trend line of Focken. <sup>6</sup> The longitudinal throwing distances of the biofidelic dummy all lay in the range of the throwing parabola determined by Focken. The throwing distance of the biofidelic dummy therefore corresponds to that of the throwing distance of the conventional dummy. The modified structure of the dummy therefore has no significant influence on the throwing distance.

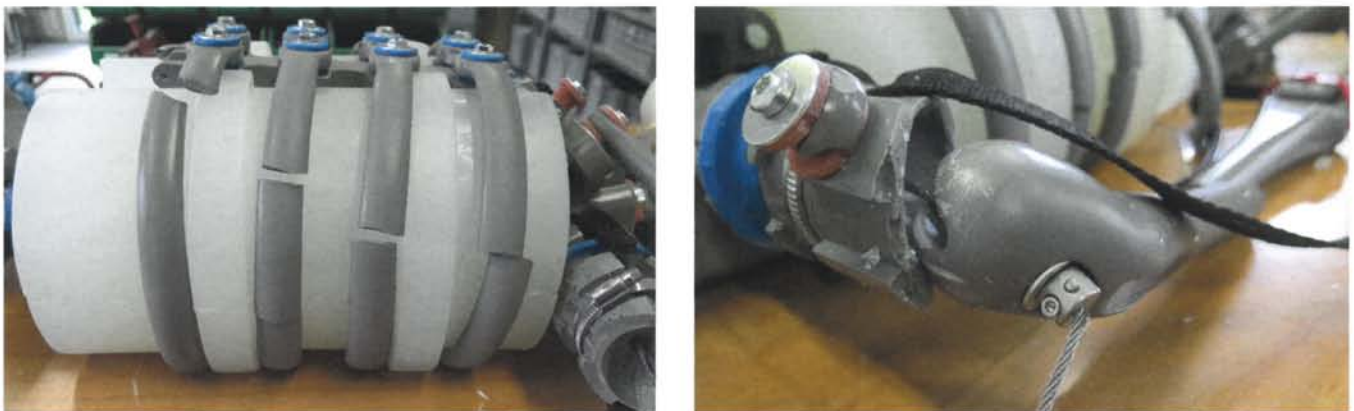
Figure 12: Biofidelic dummy with serial rib fracture and shoulder joint injuries at a collision velocity of approx. 70 kph

In this article, vehicle damages and the throwing distance of the dummies were analysed. In the crash tests the biofidelic dummies, in contrast to the conventional dummies, were "injured"; resulting in fractures and joint injuries, see figure 12. A subsequent "autopsy" of the dummy can then also allow a statement to be made on the expected pedestrian injuries depending on the collision speed. This connection was also analysed by Appel et. al.<sup>7</sup> for accidents involving pedestrians and can be used as a further verifica-
