COMPARISON OF OCCUPANT STRESS IN FRONTAL COLLISIONS WITH VARYING DEGREES OF SEAT BELT USE

DIPL. PHYS. ANNIKA KORTMANN

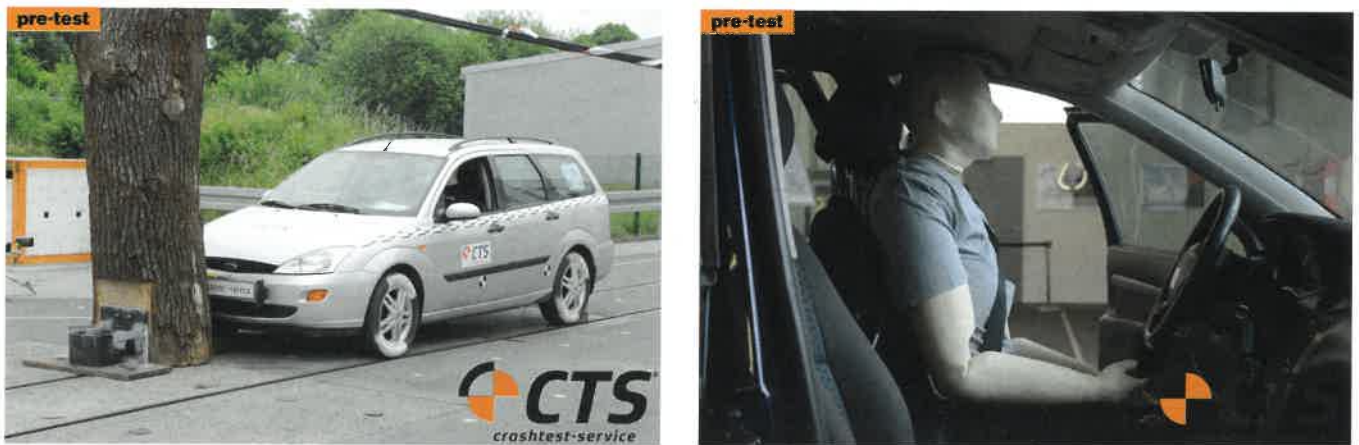
Figure 2: Collision configuration for the series of tests with a head-on collision with a tree accounting for 40% coverage of the vehicle (left) and the PRIMUS dummy used for the tests, positioned in the vehicle (right)

Three tests were carried out in which a Ford Focus traveling at approximately 50 kph was driven head on into a tree accounting for 40% coverage of the vehicle. The collision configuration can be seen in Figure 2. In all three tests, a PRIMUS dummy equipped with instruments was placed in the driver's seat to determine the head, chest and hip acceleration throughout the course of the collision. The acceleration of the passenger compartment was measured using an additional accelerometer between the front seats in the center console, at the height of the center of gravity and the results were correlated with the data measured by the dummy.

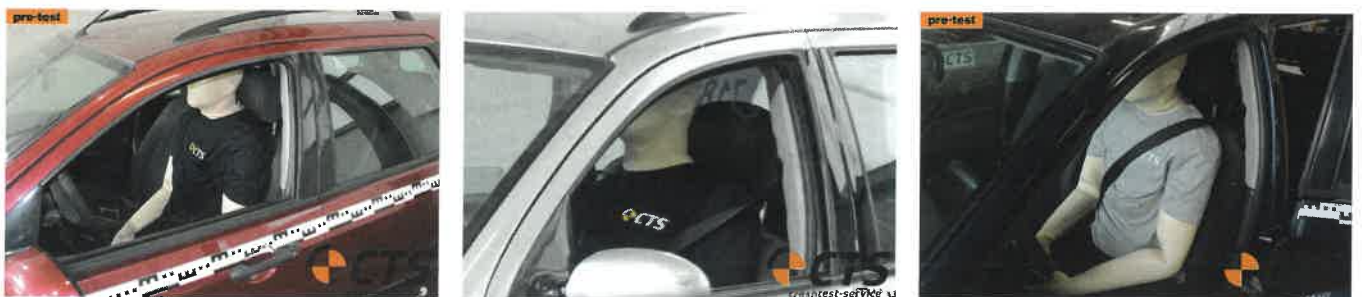
Figure 3: Degree of seat belt use for the tests: not wearing a seat belt (left), the chest strap worn under the left shoulder (middle), and the seat belt worn correctly (right)

For the tests, only the level of seat belt usage of the dummy varied. All other parameters remained the same. The differences in seat belt use of the dummy are depicted in Figure 3: not wearing a seat belt, seat belt worn under the left shoulder, and seat belt fitted properly. The test with the seat belt worn under the shoulder is designed to test the effect of a seat belt worn "poorly or in-correctly" on the passenger stress.

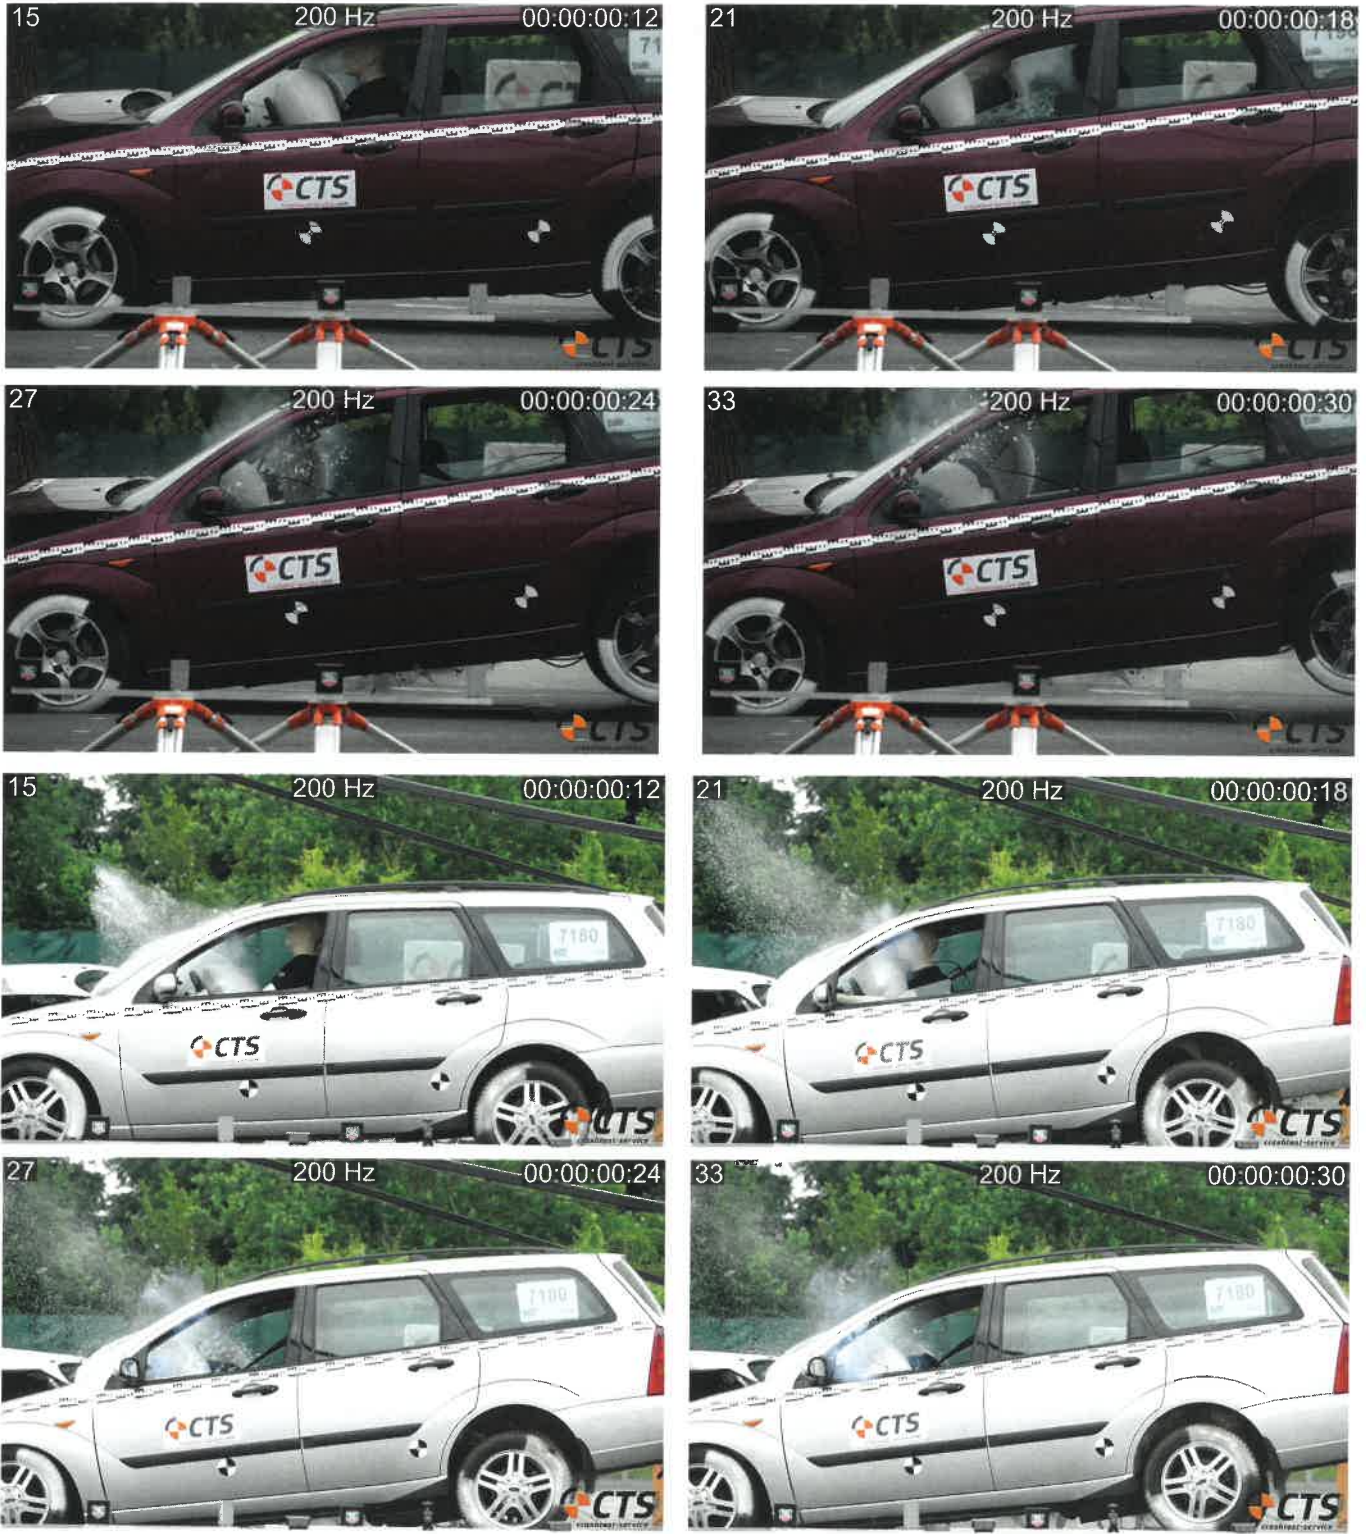
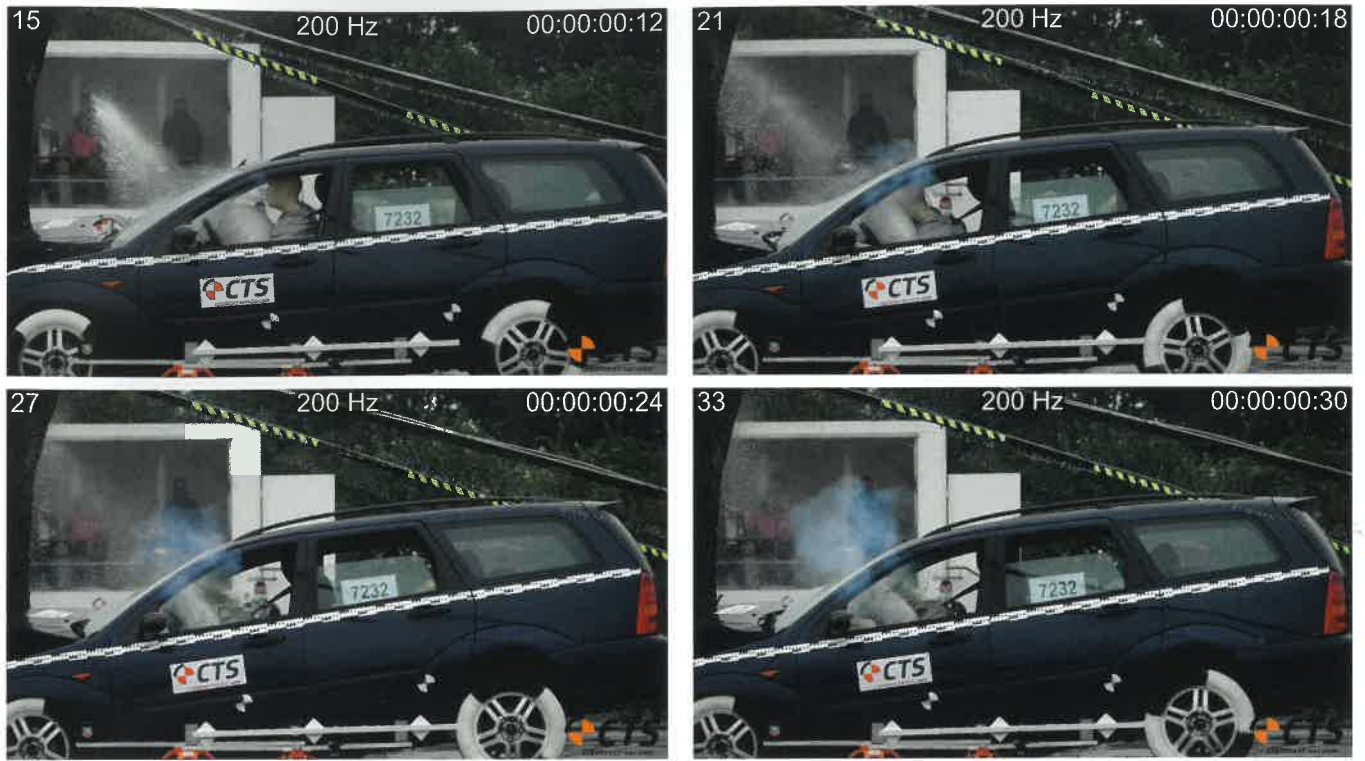
Figure 4: Motion sequence for unbelted (top), poorly belted (bottom) and properly belted PRIMUS (next page)

Figure 4 (cont.): Properly belted PRIMUS

Figure 4 shows a side view of the motion sequences of the dummies in a collision at the same points in time. In the red vehicle, the dummy is unbelted; in the silver vehicle, the dummy is wearing the seat belt under the shoulder (hereinafter referred to as "poorly belted"); and in the blue vehicle, the seat belt is being worn correctly (hereinafter referred to as "properly belted").

A clear difference can be identified in the occupant movement in the case of the unbelted dummy (red vehicle). Unrestrained, the dummy's chest collided with the steering wheel and before its head struck the roof edge and then windshield. Optically, there is almost no difference between the poorly belted dummy and the one with the seat belt worn properly (silver and blue vehicles respectively). The upper body of both occupants is obviously restrained by the seat belt. The locking mechanism of the hips of the dummies and the lap strap cause the upper bodies of both dummies to rotate forwards and downwards so that both dummies hit the opening airbag with their head.

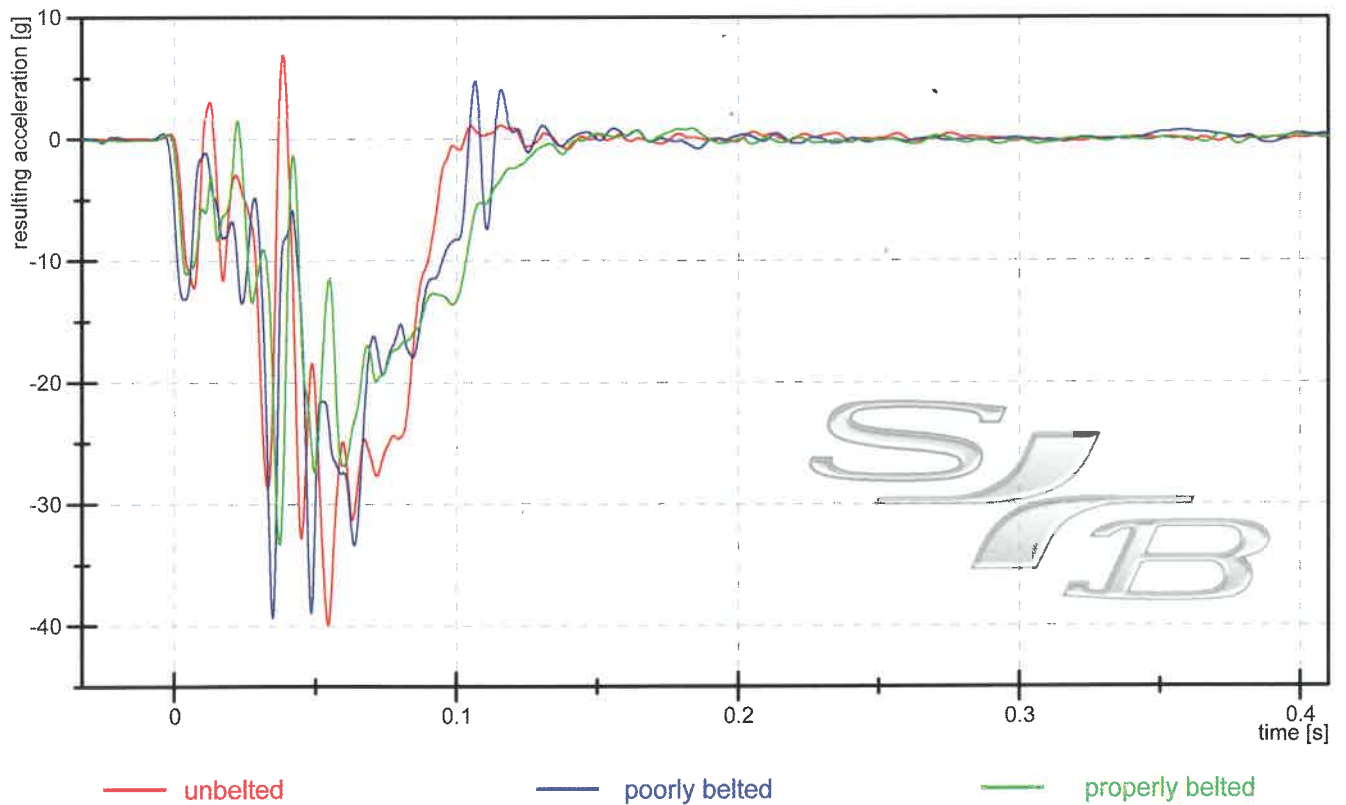
Figure 5: Acceleration sequences of the passenger compartment of the crash vehicles in the x-direction

The comparison of the acceleration sequence of the passenger compartment in the x-direction for all three tests

as depicted in the diagram in Figure 5 shows that all three crash tests can be directly compared to one another. In all three tests, the passenger compartment shows a change in velocity of around 55 kph as a result of the collision. The damage to the vehicles also corresponds optically to one another (Figure 6). The following diagrams are filtered by CFC60 (Channel Frequency Class). The customary filtering by CFC1000 for head acceleration does not provide any additional relevant information for this test so that the CFC60 filter was used instead for illustration.

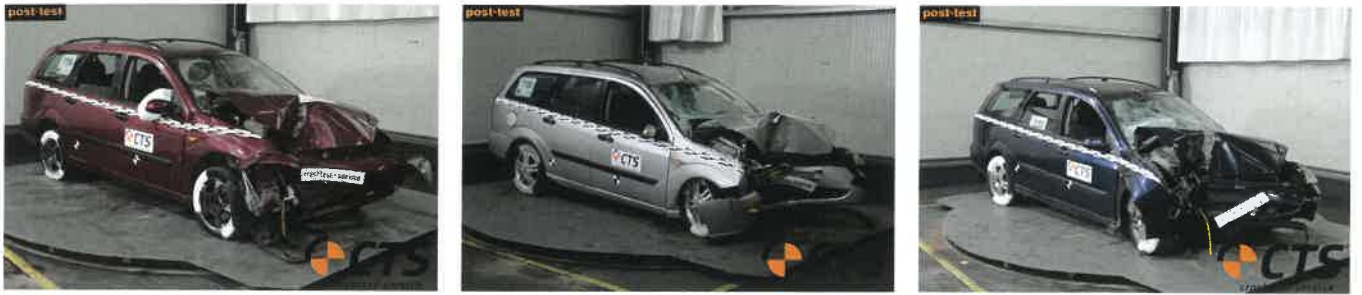
Figure 6: Comparison of the damage to the vehicles used for the crash tests

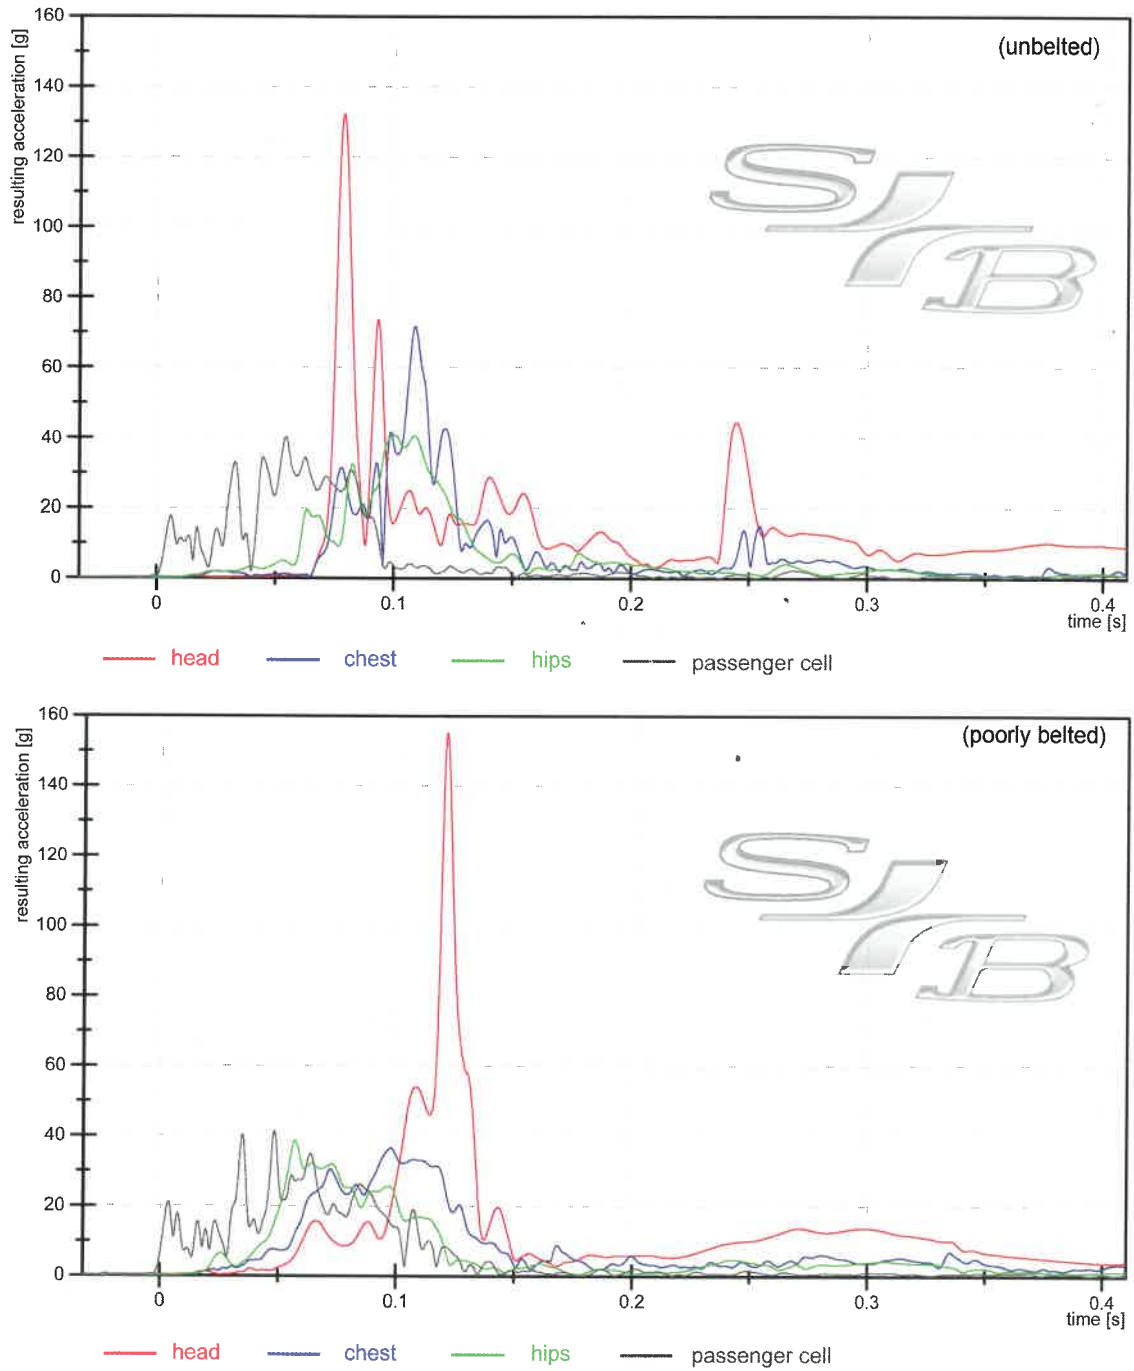
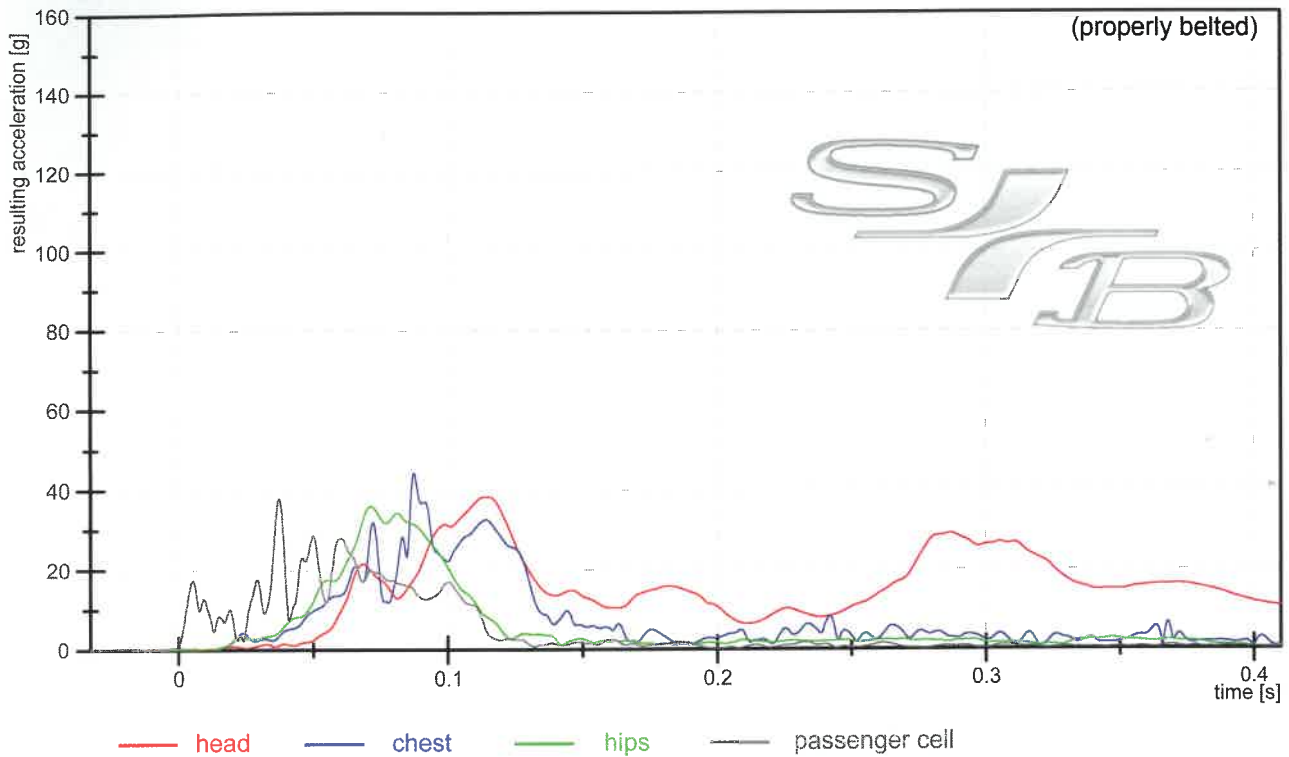
Figure 7: Comparison of the resulting acceleration of the head (red), chest (blue), hips (green), and the passenger cell (gray) for the varying degrees of seat belt use by the occupants

Figure 7 (cont.): Comparison of the resulting acceleration of the head (red), chest (blue), hips (green), and the passenger cell (gray) for the varying degrees of seat belt use by the occupants

As the acceleration sensors in the dummy and the passenger compartment are measured via the same module, it is possible to synchronize each acceleration in time with one another. The resulting acceleration sequences for the three tests are juxtaposed against one another in Figure 7. This sets out the passenger compartment acceleration (gray) in relation to the head (red), chest (blue) and hip acceleration (green). The acceleration is given in g ($g = 9.81 \text{ m/s}^2$).

From this juxtaposition, it is immediately clear that in the case of an occupant who is not wearing a seat belt or one who is not wearing it properly, there is a higher head acceleration (or to be precise, excessively high deceleration) (red graph), which does not occur in the case of an occupant with a seat belt worn properly. The deceleration of the occupant is delayed compared to the deceleration of the passenger compartment. The occupant is only connected to the vehicle through the seat belt. The delay of approximately 0.02 s before the deceleration of the occupants in the case of occupants who are wearing a seat belt can be explained by the slack in the seat belt. The tighter the seat belt, the earlier it will force the occupant to change movement in line with the movement of the passenger compartment.

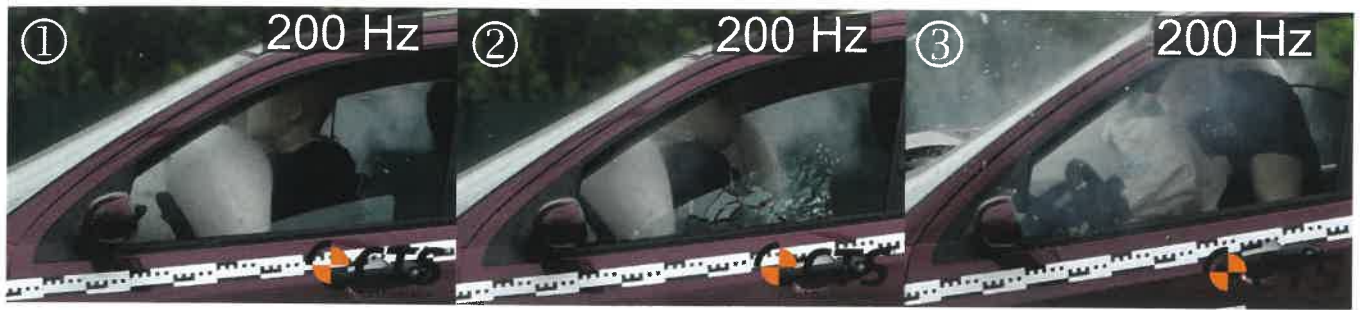
Figure 9: Multiple impacts of the head of the unbelted occupant with the roof edge (1), the windshield (2) and the roof liner (3)

Figure 8 graphically plots the acceleration sequence of the head of the unbelted occupant in x-, y- and z-directions against time. In the x-direction (red graph), three marked peaks can be identified, which have been numbered consecutively. The peaks can be allocated to the movement of the occupants based on time (Figure 9). The first peak is the impact of the occupant's forehead with the roof edge. With an impact time of 0.023 s, an average deceleration of 46.36 g (454.79 m/s²) can be derived from the graphs. The integration of the acceleration over the extremely short impact time results in a change of velocity of the head upon collision of 36 kph. All further measurements of the collision time t, maximum and average acceleration (a_{max} and a_{avg}), and the change in velocity resulting from the collision Δv are summarized as an overview in Table 1 at the end of the article.

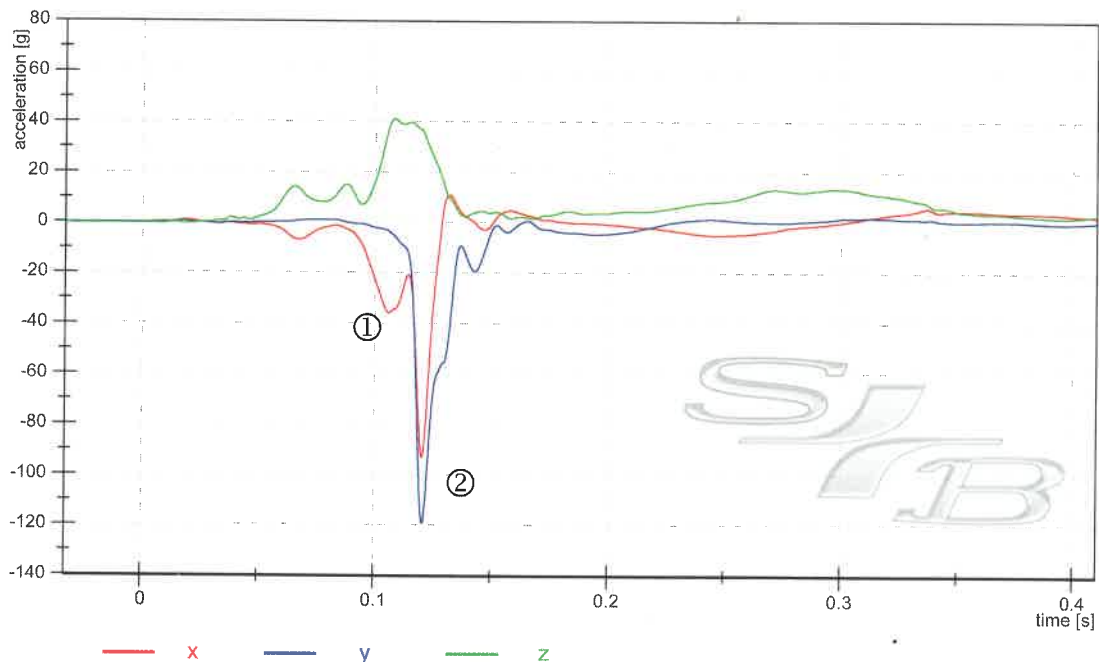
Figure 10: Head acceleration of the poorly belted occupant in x-, y- and z-directions

Figure 10 depicts a similar analysis assigning the acceleration peaks with the occupant's movement for the occupant who is wearing their seat belt incorrectly, while the related occupant movement is depicted in Figure 11. The first peak arises when the movement of the head decelerates after 0.1 s due to the airbag. A further 0.02 s later, the head is severely slowed. The head still hits the steering wheel although the airbag activated and although the occupant was using the lap strap fully and the chest strap partially.

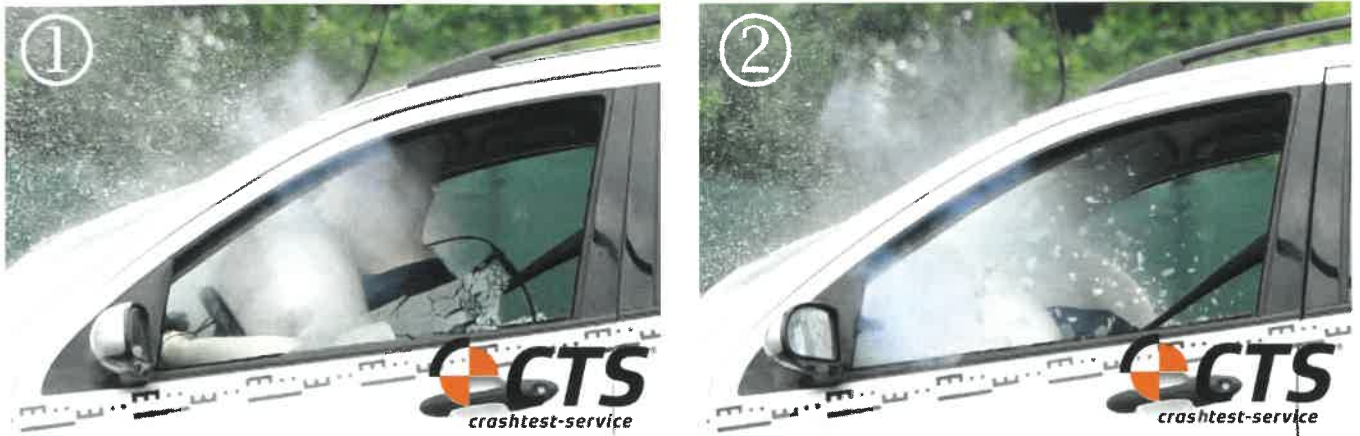
Figure 11: Impact of the poorly belted occupant with the airbag (1) and the steering wheel (2)

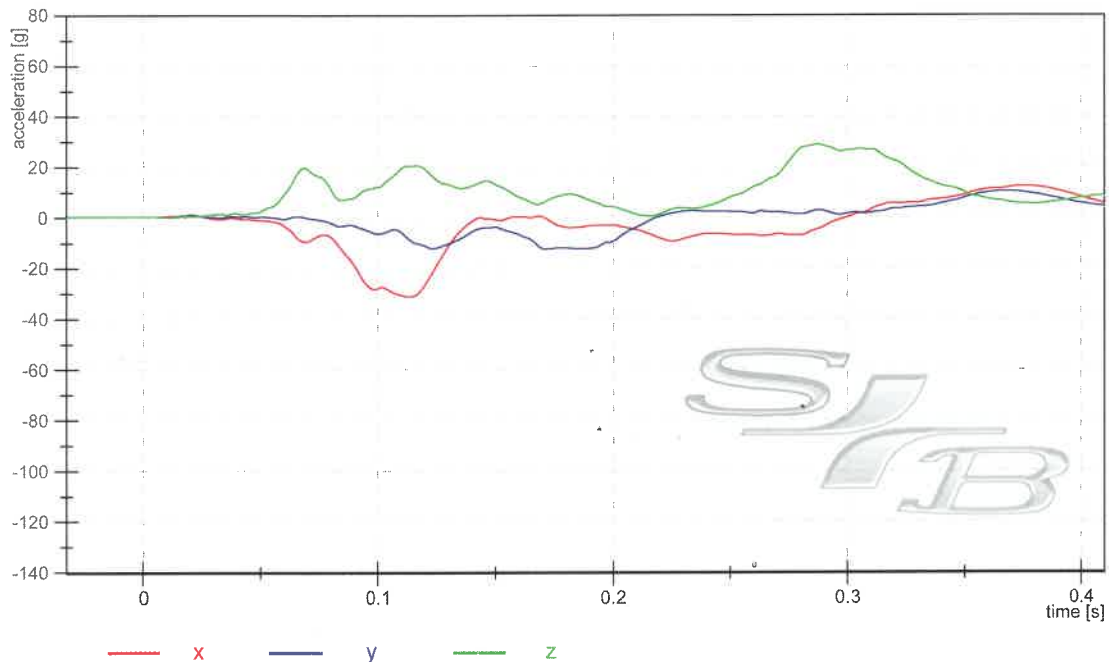
Figure 12: Head acceleration of the properly belted occupant in x-, y- and z-directions

If one depicts the acceleration sequence of the head for the occupant with the seat belt worn properly (Figure 12), there are none of the brief, strong peaks in acceleration as are noted for the occupants who were not wearing a seat belt or not wearing it properly. Instead, the head merely experiences a deceleration of up to 32 g. The head also decelerates over a comparatively long time of 0.12 s. This longer deceleration time is achieved through the combination of the airbag and the chest strap. The change in velocity of 50.15 kph caused by the collision is comparable to the impact of the head on the steering wheel of

the occupant who was not wearing their seat belt correctly. However, the longer duration results in a lower average deceleration of 11.87 g (116.44 m/s²).

The diagram in Figure 12 shows that, despite the frontal collision, the occupant also experiences deceleration in y- and z-directions, which can be quite significant. This is

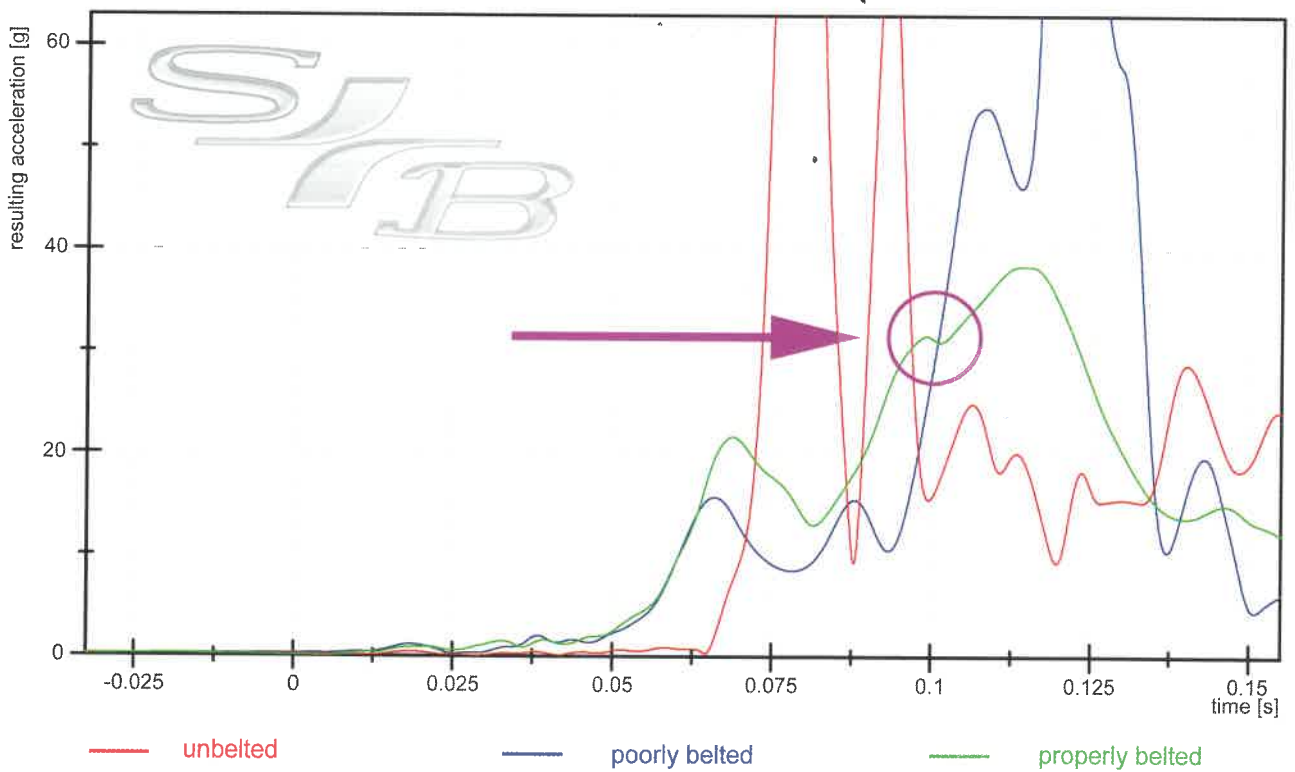
Figure 14: Enlarged excerpt of Figure 13

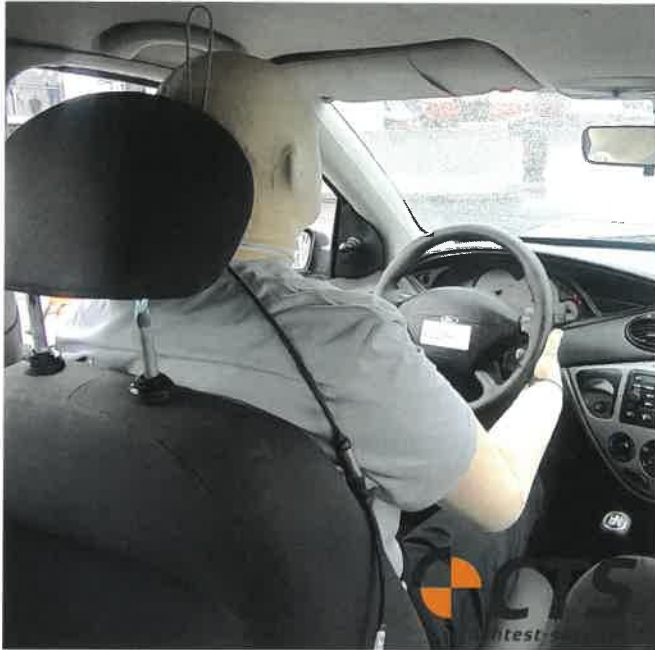
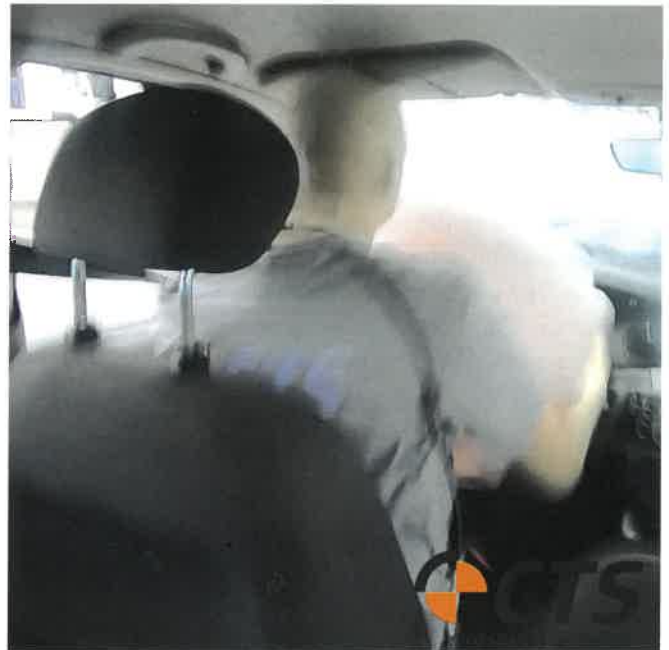
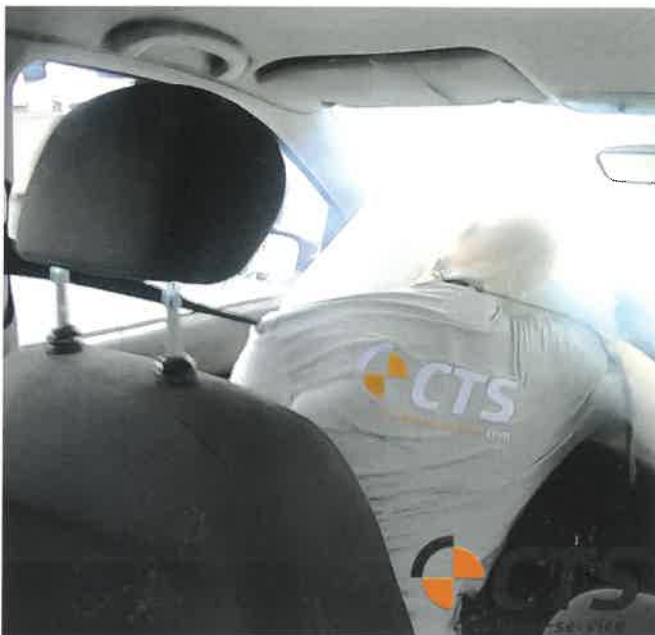
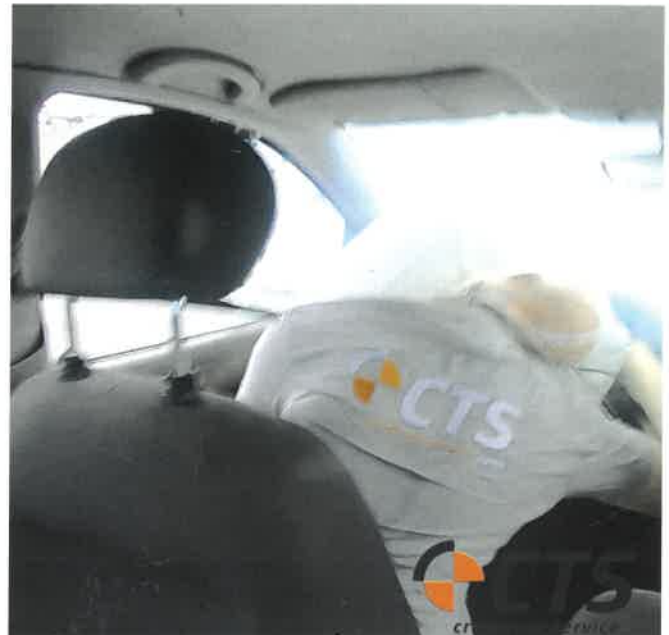
Figure 15: Significant rotation of the head when immersing in the airbag (properly belted)

because of the head movement of the occupant, which was recorded using an onboard camera in the case of the occupant with the seat belt worn properly (Figure 15).

As the head immerses in the airbag, it rotates significantly. Individual images show that the left shoulder of the occupant is restrained by the seat belt. The right shoulder swings forward, resulting, among other things, in the rotation of the upper body. The head follows this rotation, so that airbag no longer slows the head just from the front but from the right side of the head, too.

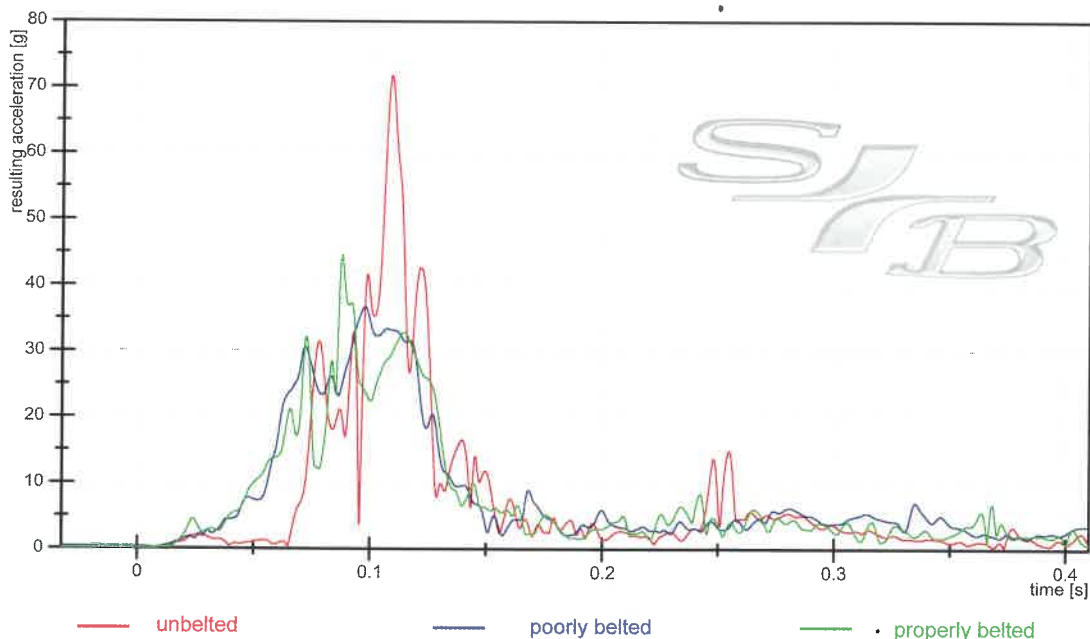
Figure 16: Comparison of the resulting chest acceleration depending on the degree of seat belt usage

The diagram in Figure 16 applies the resulting acceleration sequence of the chest depending on seat belt usage. There is almost no difference in the acceleration sequence of a poorly belted dummy (blue) compared to the dummy with the seat belt worn properly (green). The occupants are essentially held by the lap strap and the upper body cannot reach the steering wheel, regard-less of how the chest strap is sitting. The maximum deceleration in the range of 35 to 44 g occur. With an exposure time of 0.14 or 0.17 s, this results in a loss of velocity from the collision of 76.64 or 84.41 kph, with an average deceleration of 15.50 or 13.74 g respectively.

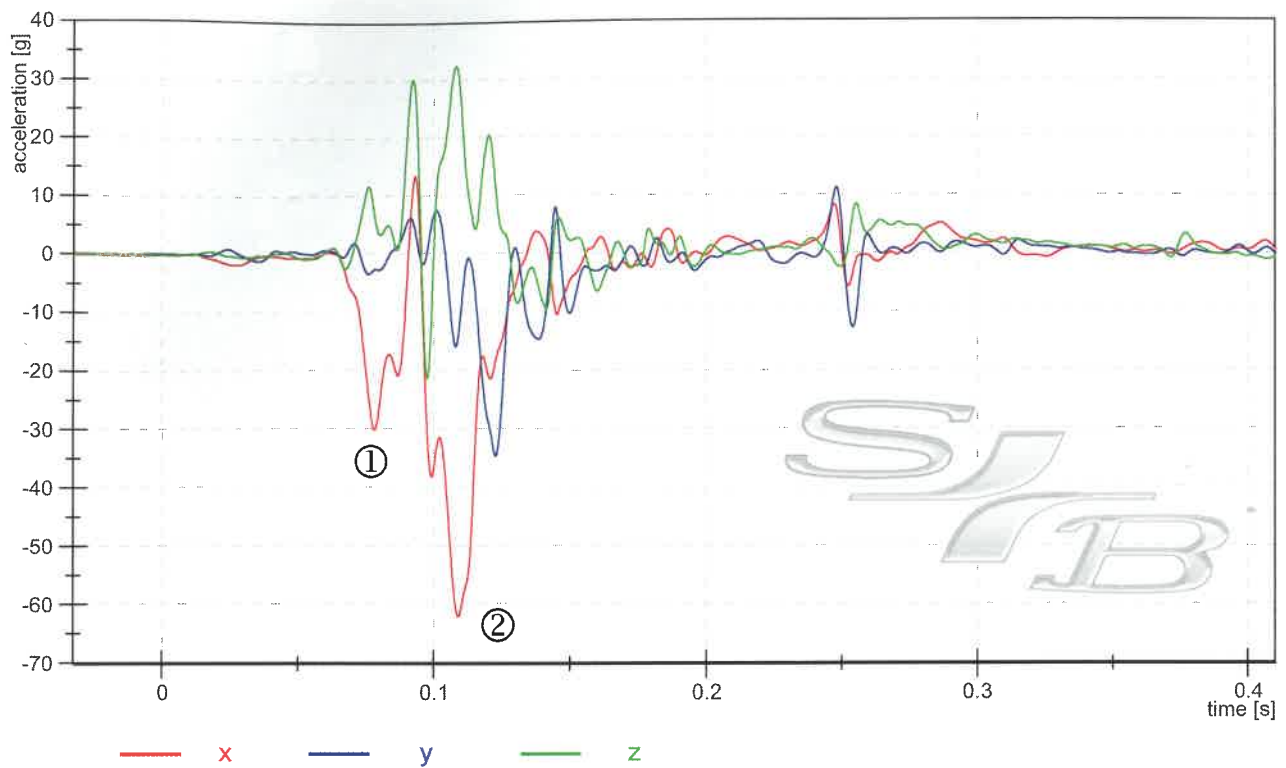
Figure 17: Chest acceleration of the unbelted occupant in x-, y- and z-directions

The acceleration sequence of the chest of the unbelted occupant is shown for each direction in Figure 17. In the x-direction (red graph), there are two characteristic deceleration peaks. The impact with the airbag accounts for first peak (Figure 18). A short time later, the airbag collapses and the chest collides with the steering wheel (second peak). When colliding with the steering wheel, the occupant experiences a change in velocity of 76.74 kph (Figure 16) as a result of the collision. The change in velocity is therefore comparable to the change in velocity in the case of an occupant who was wearing a seat belt. However, in the case of an impact with the steering wheel, the maximum delay is approximately two times larger and the deceleration time is accordingly low.

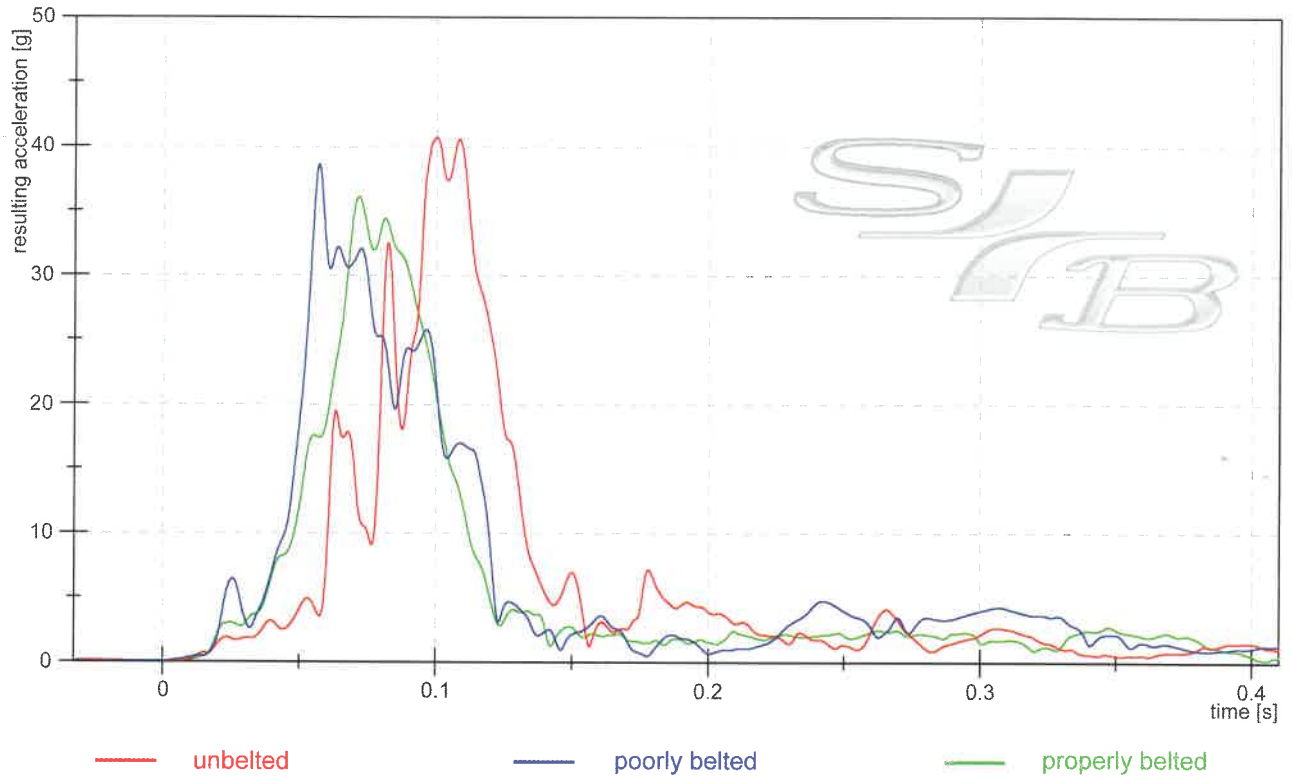
Figure 19: Comparison of the resulting hip acceleration depending on the degree of seat belt usage

As expected, there is also no noteworthy difference in the resulting hip acceleration of the dummies depending on the position of the chest strap (Figure 19 blue/green graph) as both dummies are restrained by the lap strap in the same way. At 71.34 and 65.90 kph respectively, the change in velocity of the hips as a result of the collision is close to the change in velocity of the passenger compartment (78.75 and 63.75 kph) because the hips are directly attached to the vehicle through the lap strap, apart from a small amount of slack in the seat belt.

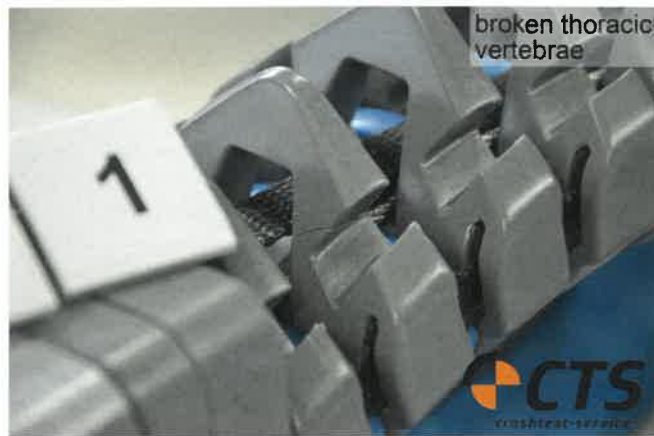
Figure 20: Injuries to the unbelted PRIMUS dummy

The autopsy showed that the unbelted occupant suffered massive hyperextension of the cervical vertebrae and a break in some thoracic vertebrae (Figure 20). The hyperextension resulted from the motion sequences outlined above (Figures 4 and 9). In comparison, the dummy that was not wearing the seat belt properly suffered two broken ribs on the left side, an injury to the elbow joint on the right, and ligament sprains in both knees (Figure 21).

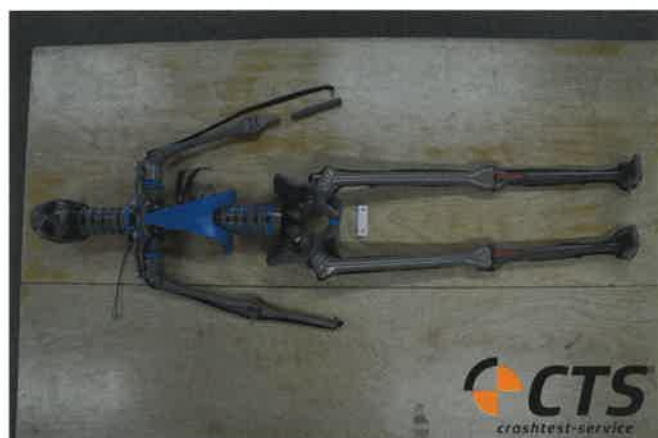
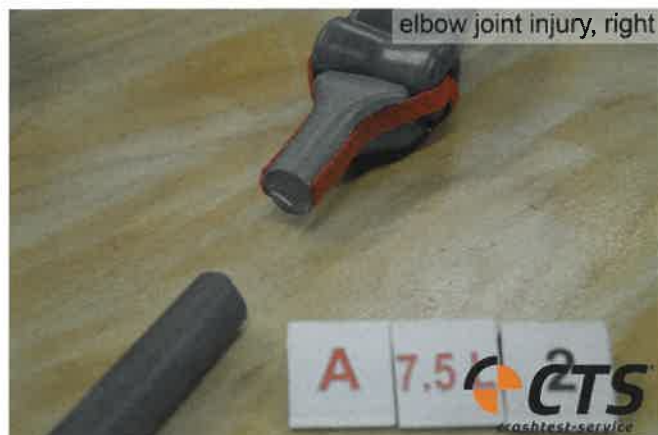
Figure 21: Injuries to the poorly belted PRIMUS dummy

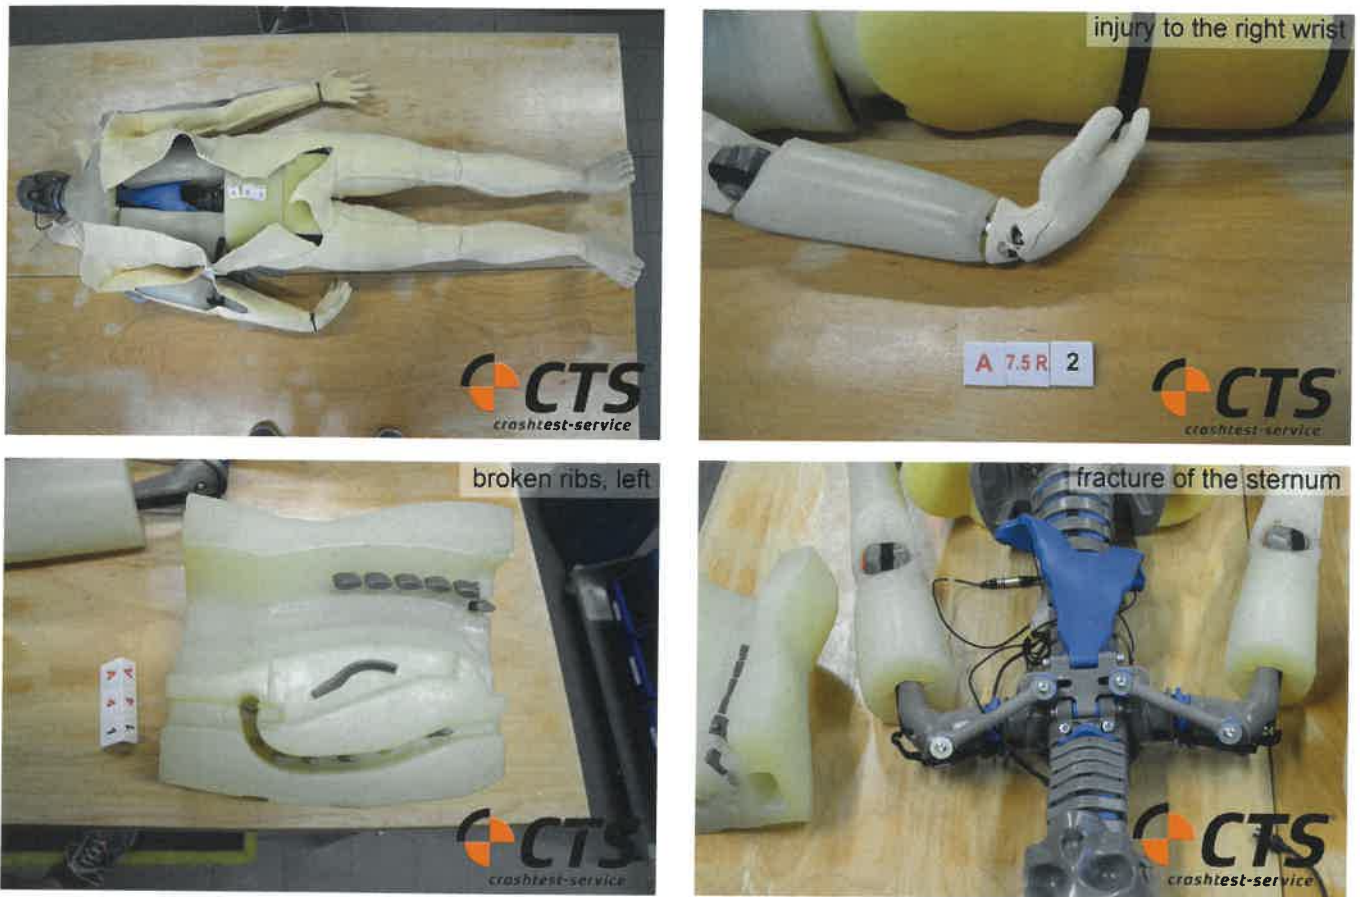
Figure 22: Injuries to the properly belted PRIMUS dummy

The injuries of the PRIMUS dummy that was wearing a seat belt properly are depicted in Figure 22. The collision resulted in two broken ribs on the left side and a fracture of the sternum.
